Urgent Field Safety Notice

Field safety corrective action

Ceiling Unit CU 5001/3 and CU 3-21/23

for ceiling mounted operating microscopes manufactured by MÖLLER-WEDEL

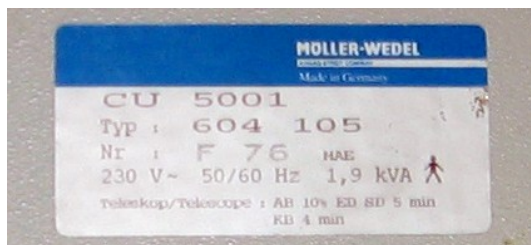
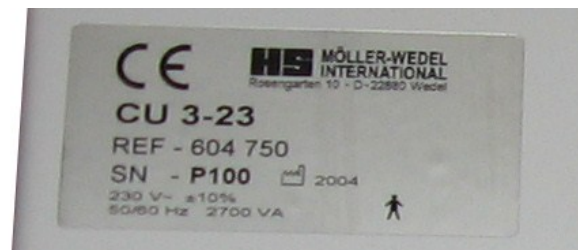
Identification plate with reference number (REF/Typ) and serial number (SN/Nr)
on the upper edge of the ceiling body

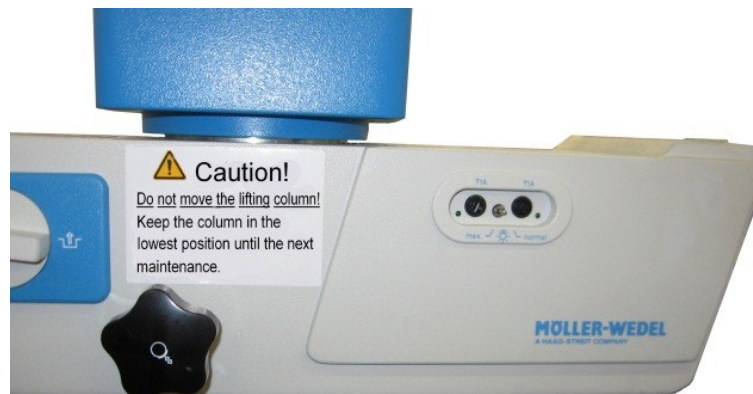
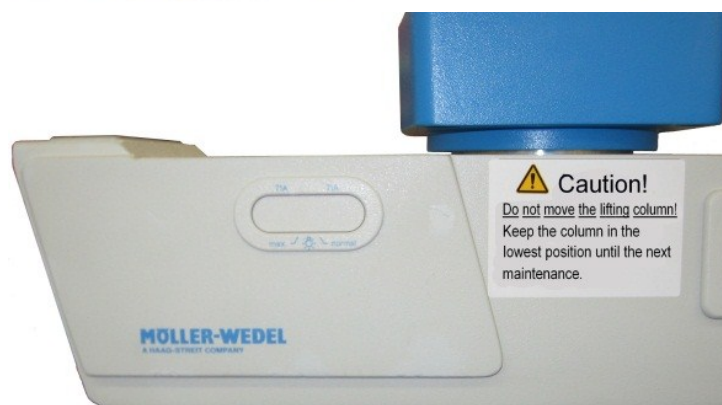
2x labels on the left/right underneath the column

1. Move the telescope column to the lowest position. The ceiling unit is now in the safe working position and can be used without restrictions.
2. Keep the ceiling unit in the lowest and thus safe working position until the ceiling unit has been serviced.
3. Use the enclosed labels on the ceiling unit to indicate that the lifting column is not to be used anymore (see annex).
4. Order the maintenance of your ceiling unit at your local representative office.
5. Please return the enclosed reply form to us as soon as possible.
