**URGENT FIELD SAFETY NOTICE**

**Name of product affected: ... Anaconda and Anaconda ONE-LOK™ Stent Graft Systems**

**FSCA identifier: CAPA 162**

**Type of Action: ... Additional instructions to enable the bifurcate body delivery system to be safely withdrawn after being fully deployed.**

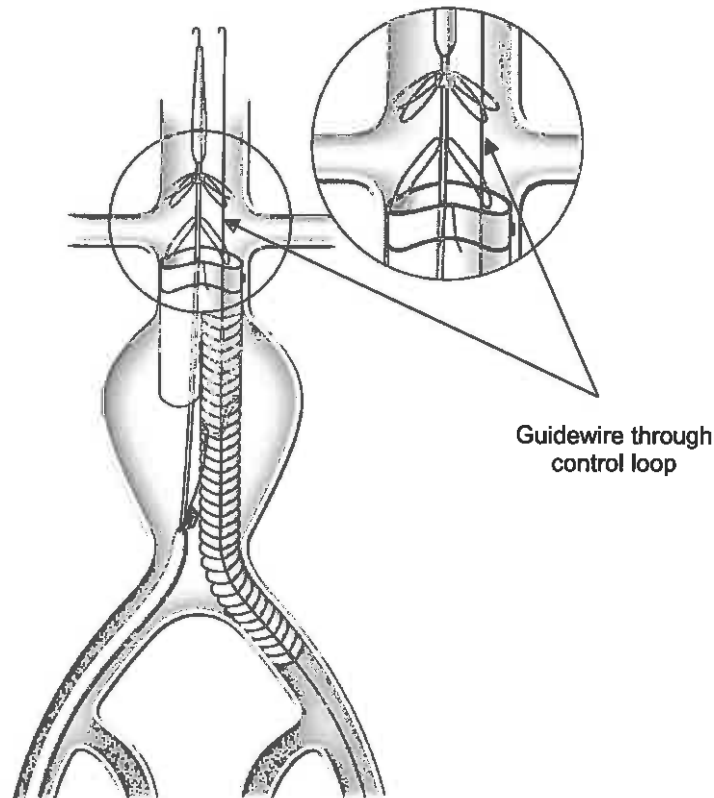
**Schematic 2: Guidewire passing through control loop.**

Upon advancement of the guidewires the Intrinsic magnet wire may pass through one of the control loops. As a result, when the Intrinsic magnet wire is withdrawn, the remaining contralateral guidewire, catheter and/or balloon will also have passed through the same loop of the body delivery system, as indicated in Schematic 2. On attempting to remove the bifurcate body delivery system from the ipsilateral lumen, it will be found it cannot be withdrawn. The loops which are tied to the body delivery system are being held by the contralateral guidewire, catheter and/or balloon in the contralateral lumen, above the bifurcate flow splitter.
