Spring Arm Modification Instructions

Ondal AC Swing on ML 301 Examination Lights

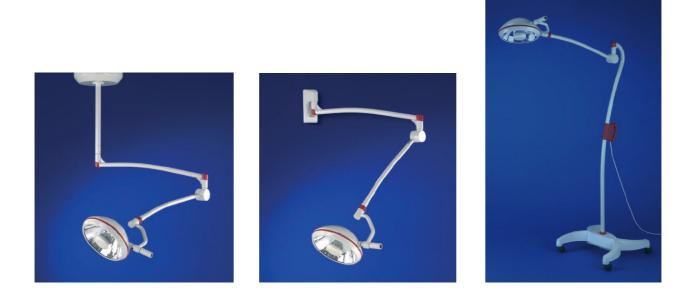
Our supplier Ondal Medical Systems GmbH recently informed us that there may be a risk of fatigue fracture in the plastic joint of Ondal AC Swing arms.

Identification of old-type spring arms with plastic joint in comparison with new spring arms with metal joint.

The Ondal AC Swing spring arm with plastic joint has a curved tube.

The Ondal AC Swing spring arm with metal joint has a straight tube.

For this reason, the spring arm must be replaced as a precautionary measure.

For all ML 301 examination lights with a curved spring arm, the spring arm must be replaced with a straight-tube version.
