Urgent: Field Safety Notice / 002-13

Product name:	IH-1000
Product REF:	001000
IH-1000 software version:	all versions

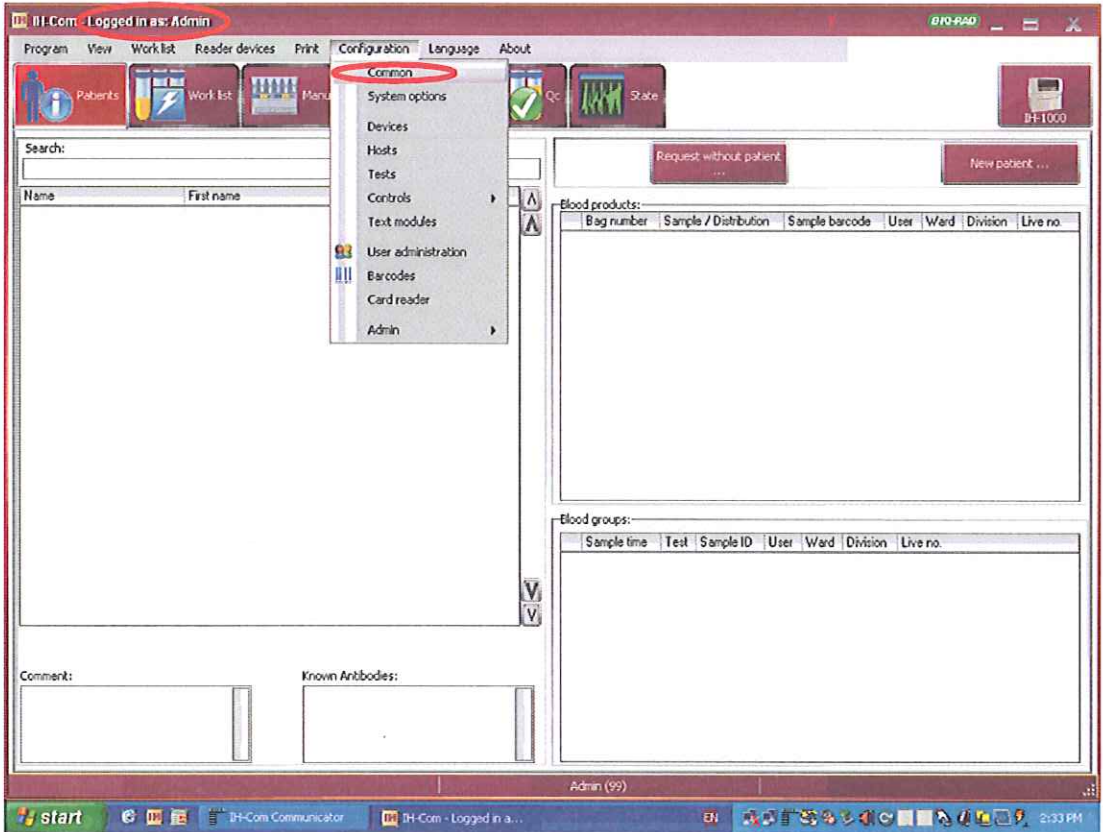
Illustration of IH-Com selection “second reading” function

- 1. Log in as **“Administrator”**.
- 2. In the toolbar click on **“Configuration”**, then, choose **“Common”**.

3. Activate the “second reading” function **for all the test results**, this means that the results must be read again and accepted by the user before the sending to the host.

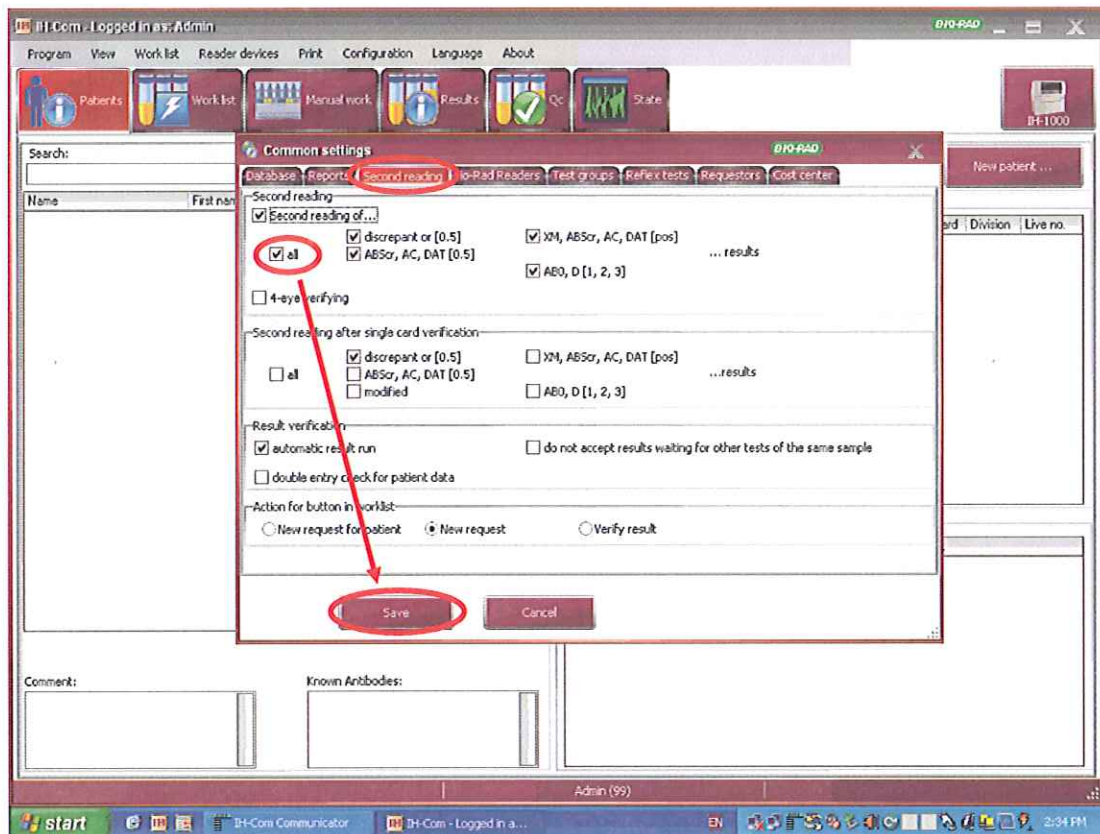
Illustration of IH-Com “second reading” function

4. Check the consistency between the result in the well/card and the result returned by the system.
