Urgent Field Safety Notice

Deep Brain Stimulation (DBS™) Lead Kits: Models 3387, 3387S, 3389, 3389S, 3391, 3391S

Potential Lead Damage Associated with the DBS Lead Cap: modified instructions

Medtronic reference: FA565

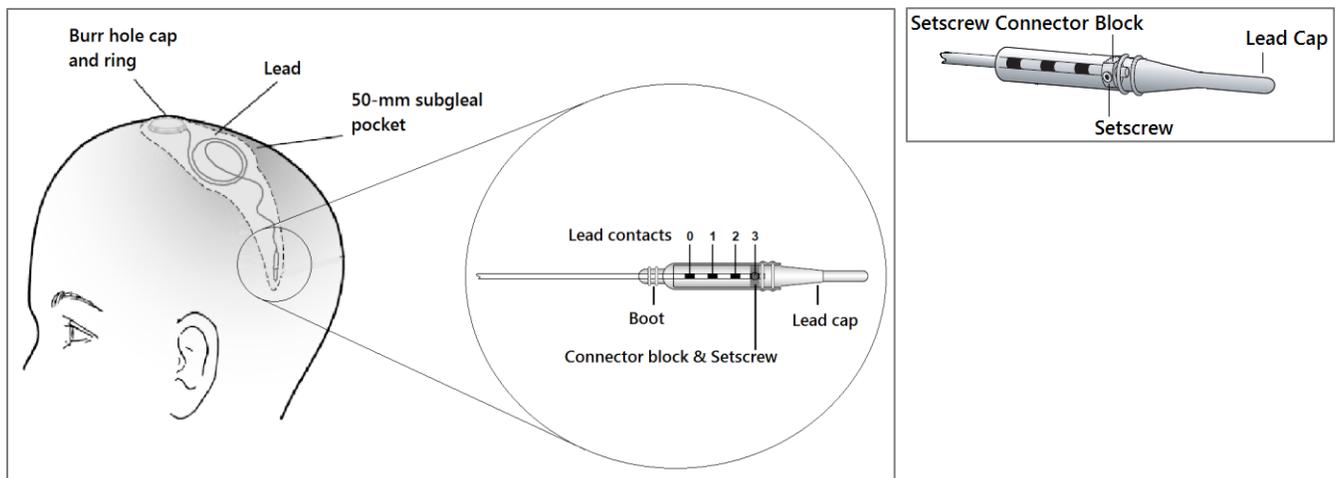
Medtronic has received reports of DBS leads being damaged at the connector end of the lead when the lead cap is used. The connector end of the lead is the end of the lead connected to the lead extension. Tightening or loosening of the setscrew may twist the setscrew connector block and may damage the proximal connector end of the lead. If this happens, the damage would most likely occur at lead contact #3 which could affect electrode contact #3.

Depending on the extent of lead damage and the need to use electrode #3, lead replacement may be required or optimal therapy may not be provided. Lead damage due to setscrew connector block twisting has been reported with 0.25% of the DBS leads distributed, however, this incidence is lower than the expected actual rate of occurrence since every event is not likely to have been reported and the actual number of uses of lead caps is unknown. Physicians should recognize that every use of the lead cap provides an opportunity for lead damage to occur. To date, there have been no reports of permanent patient impairment, life-threatening injury, or death as a result of this issue.

There is no action required for existing patients in the absence of concern over potential lead damage. Medtronic is working on corrective actions to reduce the occurrence of setscrew connector block twisting which may result in lead damage. Until these corrective actions are in place, follow the modified instructions below:
