Urgent Field Safety Notice (FSN)

Product Name: DePuy Specialist 2 Intramedullary Rod (SP2 IM Rod)

FSCA-identifier: DVA-107305-HHE

Date: Feb 2013

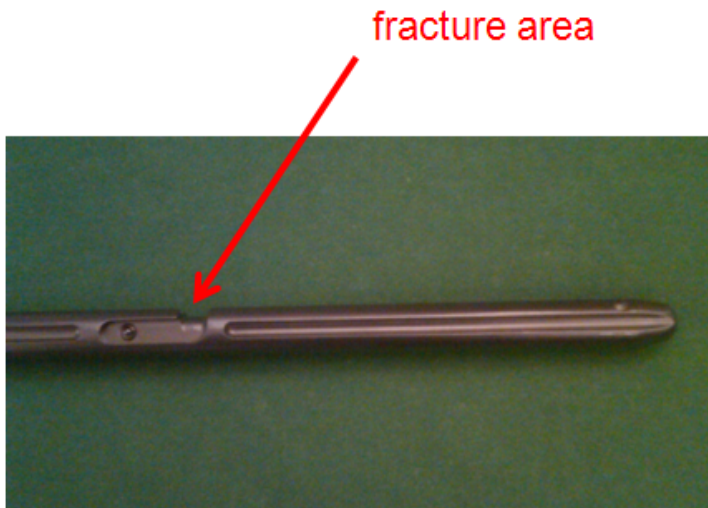
Attachment B: Photograph of SP2 IM Rod and potential fracture area

Background: DePuy has identified the potential for the SP2 IM Rod to fail due to fatigue when excess leverage is applied at the tip. There is a deep J shaped groove at the tip of the rod, which allows a sleeve to lock into place when used in revision cases (see picture Appendix B). It is at the top of this groove that fracture can occur. DePuy has received 9 complaints since 2008 regarding the tip breaking with 8 complaints where the tip was left in the patient.

1. Avoid using excessive force to drive the rod into the IM canal. If a large amount of force is required to insert the rod, the femoral canal may be overly bowed, or the distal entry hole may be too tight to permit the rod to center in the canal. Should this be encountered, using a shorter IM rod may be more appropriate. Enlarging the distal entry hole may help as well.

2. The rod tip is much stronger when the sleeve slot is in compression. This can be achieved by making sure the slot on the modular handle (the landmark for locking the rod to the handle) is facing medially when the rod is inserted on a right knee, or laterally on a left knee.

3. Do not use the rod as a slap hammer to remove a well-fixed SP2 distal femoral locating device. This can lead to high stress concentrations in the rod tip. If set pins are well-fixed to the distal femur, use a rongeur to release the set pins.

4. The rod should not be used as a femoral distractor to pull the femur away from the tibia. In lieu, use a bone hook or use a U-shaped retractor.
5. Check the condition of the rod on a regular basis. Return any rods showing signs of cracks in the distal tip near the sleeve groove.
