URGENT FIELD SAFETY NOTICE: RA2013-033

Product Description: OASYS MIDLINE PLATES
Reference No.: 4855104(4)-(8) & 4857104(4)-(8)

RA2013-033 –OASYS MIDLINE PLATES

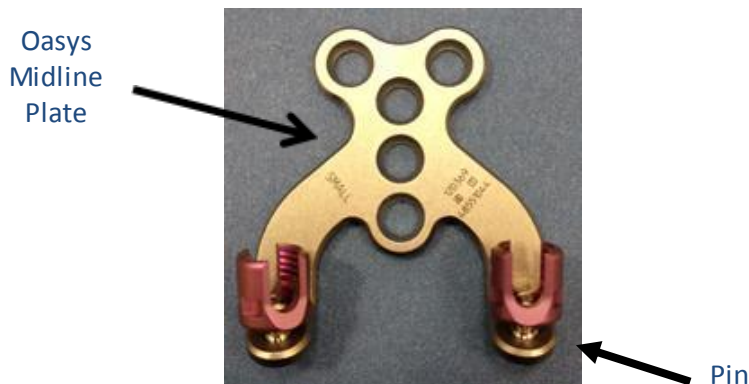
Customer reports for revision surgeries due to pin breakage have exceeded pre market identified thresholds. The pin connects the tulip head to the Midline Plate.

An internal investigation has been initiated to determine the root cause for discrepancy and to ensure that appropriate corrective actions are put into effect. Pending the results of this investigation a removal action is taken as a precautionary measure in order to preserve patient safety.

1. Immediately check your internal inventory and quarantine all subject devices pending return to Stryker
2. Circulate this Field Safety Notice internally to all interested/affected parties.
