URGENT FIELD SAFETY NOTICE

SAM Junctional Tourniquet (SJT) Auxiliary (Accessory) Strap

2014/11/06

Device Modification/Exchange/Destruction

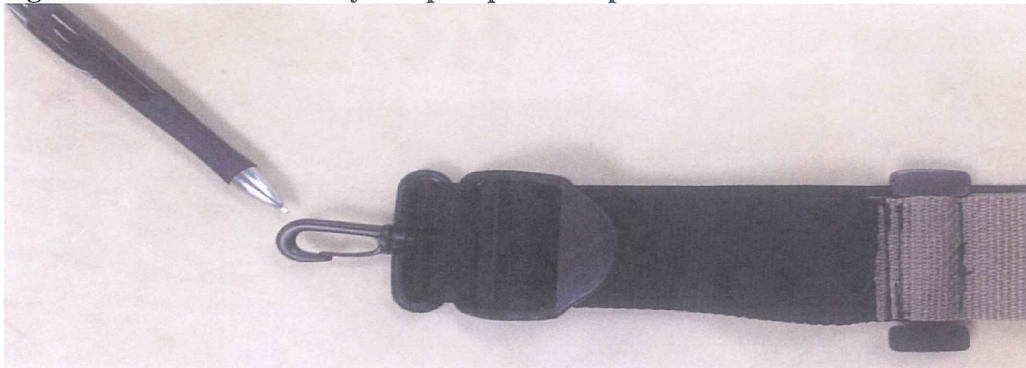
Figure 1 – Current Auxiliary Strap Clip Close Up

It was determined through customer feedback and subsequent internal testing that the rear retaining clip (shown below in Figure 1 and Figure 2) failed in a very small number of devices during training demonstrations. No reports of patient injuries have been received by SAM Medical nor has the device been reported to fail during actual patient use. SAM Medical is taking a proactive approach by offering a replacement strap for all SJT units shipped to our customers.

The device failure itself will be readily recognized because the failure of the clasp will either prevent initial tightening of the strap or will cause the strap to detach from the SJT, resulting in an immediate loss of pressure to the axilla area.

Failure Investigation findings: Investigation into the two reported product failures revealed that the failure was due to a flaw in manufacturing process for the clasp (plastic construction).

Customers will receive one complete Auxiliary Accessory Strap at no charge with a reinforced metal clip as a replacement. Once received, the existing strap should be removed from the SJT and replaced with the new strap. SAM Medical is making best efforts to quickly produce replacement straps for all affected units and to get them to all affected customers.

SAM Medical is actively working to upgrade the clasp in question in order to ensure full functionality and structural integrity going forward. All replacement straps will be of the same upgraded construction.

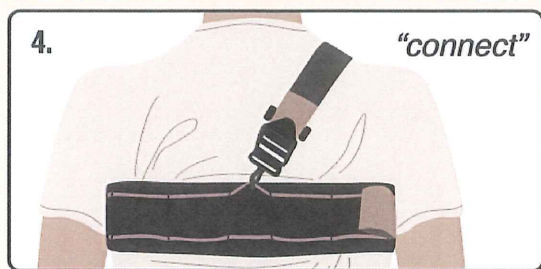
Figure 2 – Auxiliary Strap Application

Connect the auxiliary strap to the cord on the back of the SJT using the small clip, as close as possible to the patient's mid-line.
