Field Safety Information No. 4 / 2014

Manufacturer: CODAN ARGUS AG

Product: Syringe pump:
green stream SY-P ARGUS 600, Firmware version 1.00 – 1.51
ARGUS 600, Firmware version 3.01 – 4.32

Subject: Missing “syringe alarm” due to wrong replacement parts

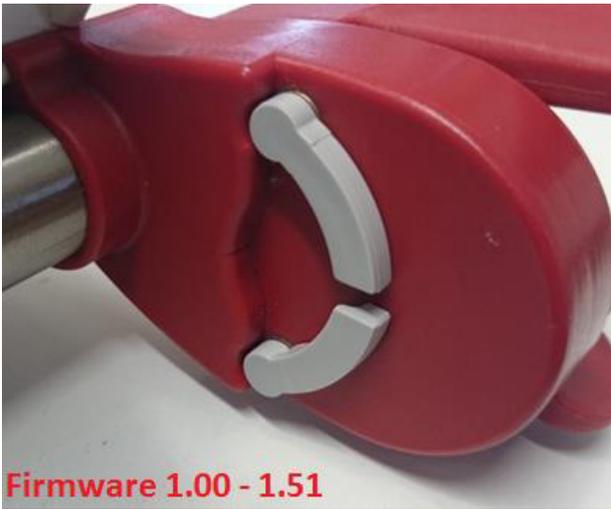
Investigation of an adverse event revealed that FW3/FW4 clamps were used in one European hospital as replacements for broken FW1 clamps resulting in the “syringe alarm” not activating – even though the syringe was mounted improperly it was possible to start the infusion.

<p>The pump green stream SY-P ARGUS 600, firmware version 1.00 – 1.51 must be equipped with clamps (grey parts) as shown in the figure below.</p>	<p>The pump ARGUS 600, firmware version 3.01 – 4.32 must be equipped with clamps (grey parts) as shown in the figure below.</p>

<p>If clamps match with FW Continue to use the pump. If a defect occurs until June 2016, remove the device and dispose of it according to WEEE Regulations 2013.</p>	<p>If clamps match with FW Continue to use the pump. Perform the Standard Safety Check according to the maintenance specification by the manufacturer.</p>
<p>If clamps do not match with FW Remove the pump from service and dispose of it according to WEEE Regulations 2013.</p>	<p>If clamps do not match with FW Remove the pump from service and replace the entire housing drive unit followed by a Standard Safety Check. The housing drive unit is designated as part number 10.152 (also known as 600937).</p>

<p>Dispose of all available non preassembled clamps Plan for decommissioning of the pumps in June 2016.</p>	<p>Dispose of all available non preassembled clamps Plan for decommissioning of the pumps in 2019.</p>
