Safety Advisory Notice

To all users of the SIEMENS Ysio Max, Luminos dRF Max, Luminos Agile Max, Uroskop Omnia Max with software version VE10A to VE10C

Re: Malfunctions in Ysio Max, Luminos dRF Max, Luminos Agile Max, Uroskop Omnia Max

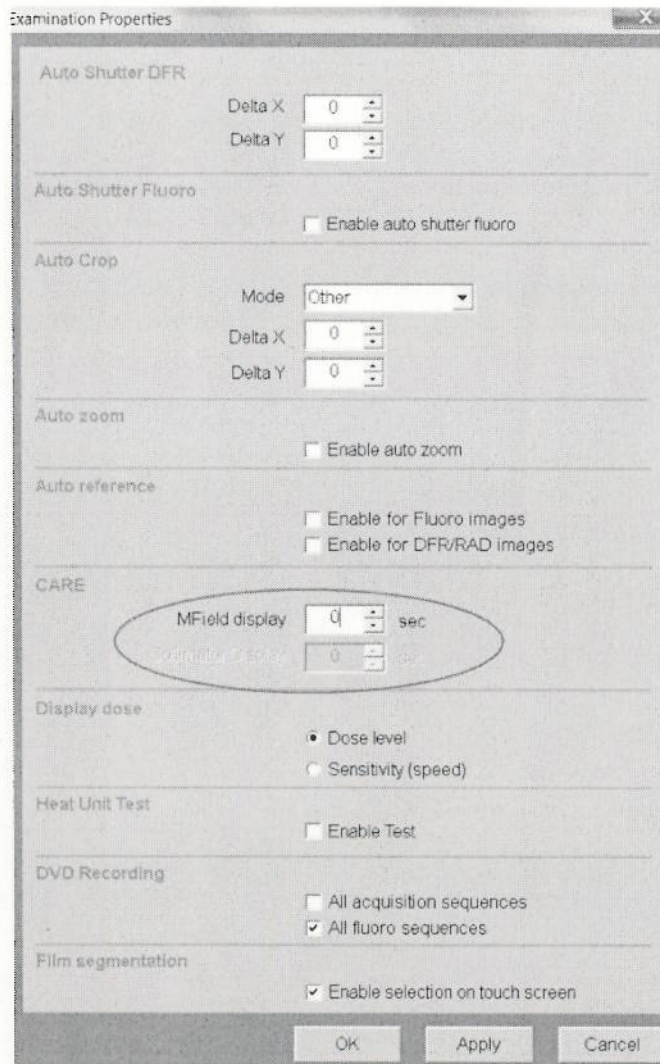
2. Incorrect labels and annotations (Ysio Max is not affected)

Under certain circumstances the image label (L, R) and annotations are displayed incorrectly after images have been sent to PACS or hardcopy/filming. This might lead to potentially incorrect diagnosis.

- Please disable the **Measurement Field Display** and **Collimator Display** by setting the display time for both settings to **0 sec** (if editable).

This setting can be found under **Patient mode** → **Settings** → **Examination Properties** (also to be found in FLUORSPOT Compact Operator Manual chapter 4.9.4):
