## **Urgent Field Safety Notice (FSN)**

**Product Name:** GLOBAL APG+ 2.5mm Breakaway Guide Pin

**Date:** April 2014

**FSCA Identifier:** DVA-108588

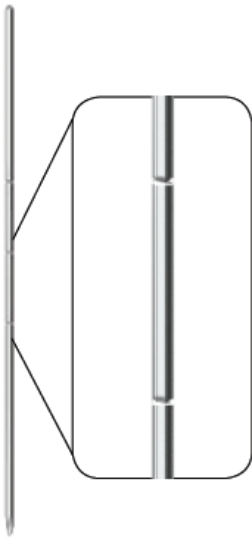
**Figure 1: Image of GLOBAL APG+ 2.5mm Breakaway Guide Pin from the GLOBAL® APG+ Design Rationale and Surgical Technique**

DePuy Orthopaedics, Inc. is issuing a voluntary device correction for the GLOBAL APG+ 2.5mm Breakaway Guide Pin (single-use shoulder instrument). The Field Safety Notice is being issued to inform users about the possibility of the pin breaking and potentially being left in the patient. Information regarding the affected instrument's use will be included in the following surgical techniques:

- “The grooves on the 2.5mm Breakaway Guide Pin are exclusively used for the breakaway feature and are not intended to indicate the depth to which the pin should be inserted.”
- “The pin is designed to break at the grooves. Be aware that it may break unintentionally if subjected to too much bending force.”

- “After use of the guide pin is complete, confirm that all sections (totaling the full length of the original, unbroken pin) have been removed.”

The company suggests that if there are any doubts of broken or missing pieces during the procedure, or when inspecting the instruments during or directly after surgery, then radiographs (X-Rays) should be taken with proper techniques to ensure there are no pieces left in the patient. Once this is complete, the patient should continue to be treated per the standard of care.
