Urgent Field Safety Notice

GD4500 Rev B

Date 2014-08-13

Getinge is initiating a field safety correction with regards to Washer-Disinfector of GETINGE Getinge 46-Series (46T excluded) with PACS 300/350 control.

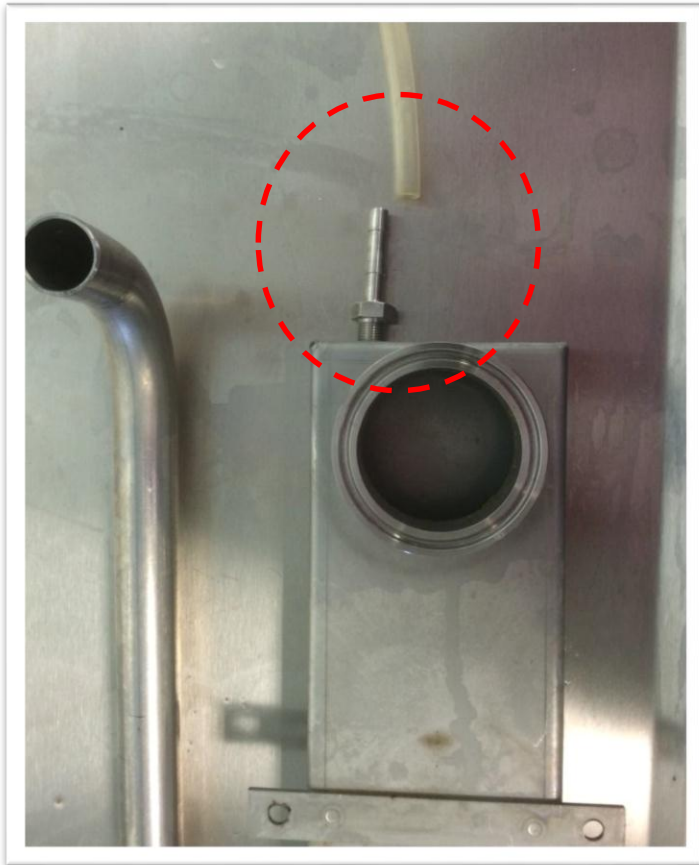
We have however now after performing detailed root cause analysis identified the problem as insufficient water flow throughout the manifold due to formation of air-pockets where sedimentation may occur. Use of detergents that are not recommended might also have negative impact.

Figure 1: vent hole added on top of manifold to prevent trapping of air.

- Cleaning of the manifolds.
- Adding ventilation-hole at the top of the manifold and linking it to the chamber i.e. preventing the formation of any air-pockets and secure a continuous water flow. See details in appendix 1
- Getinge will amend the instruction for use regarding the use of detergents, including a list of recommended detergents.

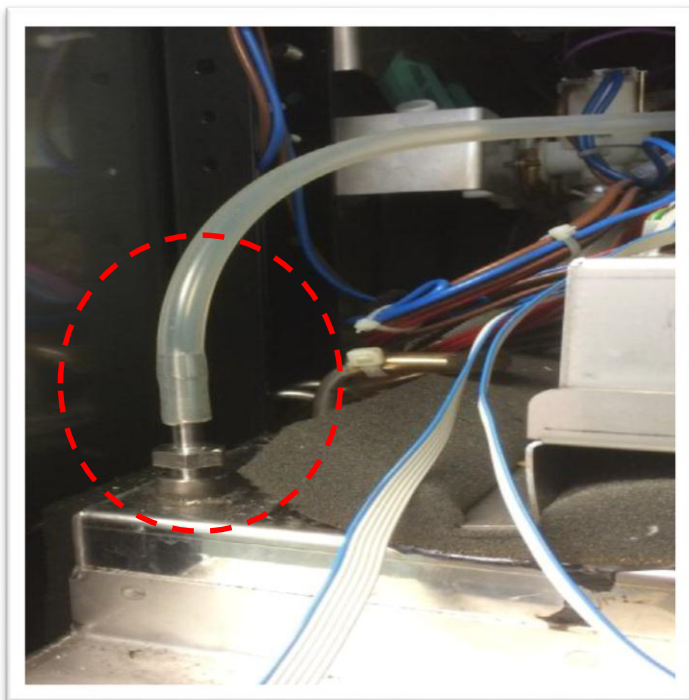
Figure 2: The vent hole is linked back to the chamber through a pipe
