URGENT: FIELD SAFETY NOTICE

MSA/2014/001/IU

| SUBJECT | Preventive Action: - Replacement of MAQUET STANDOP VOLISTA spring arms |

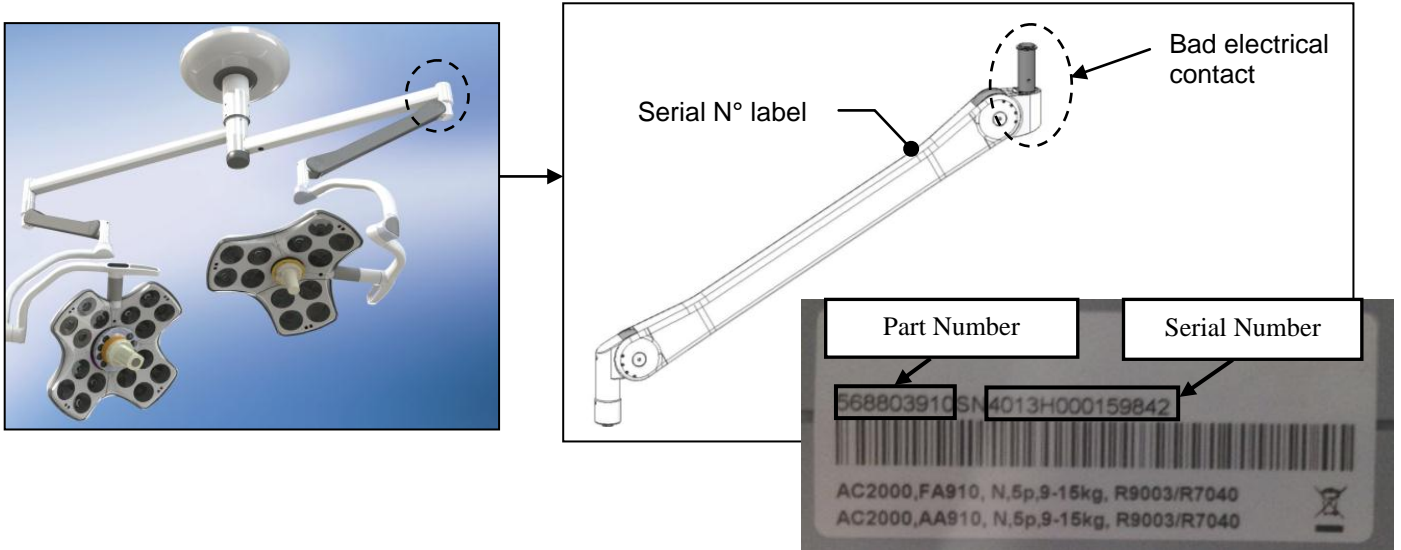
MAQUET identified that some STANDOP VOLISTA spring arms were defective.

The failure affects the 5-pole plug connectors and can generate a gap, allowing a potential electrical disconnection during use of the device. Depending on the width of the gap, a malfunction may not be detected during the installation activities.

A defect on the 5-pole plug connector, in case it is not detected during the installation activities, may result in a sudden extinction of the light during an operation.

Although MAQUET estimated that there is a low probability that the situation causes harm to a patient, MAQUET decides to replace all the potential defective spring arms.

Please immediately verify on the product label that your STANDOP VOLISTA light is in the scope of this Field Safety Corrective Action, and contact your local MAQUET office or distributor in order to organise a replacement.
