Urgent Field Safety Notice

10819177, Rev. A

ADVIA Centaur®
ADVIA Centaur® XP

Improper Manual Loading of Sample Racks

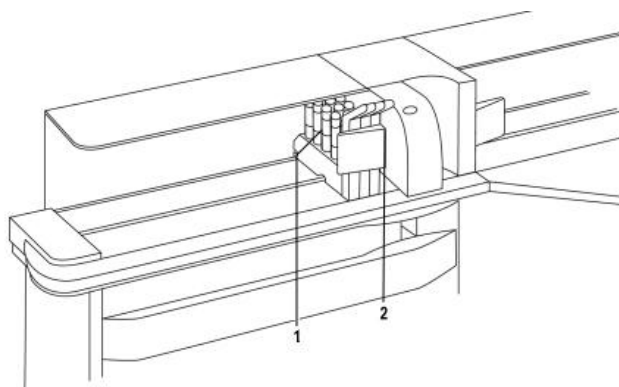
Figure 1. Sample Entry and Inprocess Queues

Pushing the sample racks may cause misreads of Sample IDs (SID) if the sample rack loading instructions are not followed exactly as described in the ADVIA Centaur or ADVIA Centaur XP Operator's Guide. Refer to Figure 1 in the Actions to be Taken by the Customer section.

If a sample rack is manually pushed with a slight forward nudge to the entry position without placing it on the rack positioning guide, the barcoded tube SID can be assigned to different positions in the rack. This may lead to misreported results.

When loading a sample rack, ensure the sample rack notch rests on the raised area of the sample entry queue (1) and the system automatically moves the rack to the loading position. This raised guide ensures the sample rack is positioned correctly and will accurately scan each barcode as it enters the inprocess queue (2). **Do not** push the sample racks into the system.
