# **Field Action Notes**

Product: S4934 Rinse solution for ABL555, Lot LW-01 October 8, 2014

**Subject:** Rinse solution bottles have been produced with an incorrect adaptor at the top.

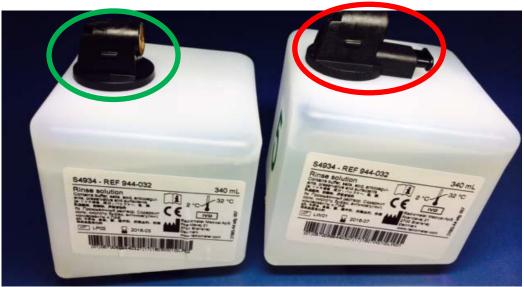
RADIOMETER has recently become aware that one lot of Rinse solution bottles has been produced with an incorrect adaptor. The incorrect adaptor has an enzyme

dispenser filled with enzyme attached to it.

The enzyme will degrade the enzyme in the glucose and lactate membrane units. This causes the glucose and lactate results to be gradually affected and potentially false low results may be reported. The false low results will potentially be obtained in the timespan from where the degradation has led to a too low sensitivity of the glucose and lactate electrodes to the next calibration. This timespan will be maximum 4 hours. Upon a calibration with low sensitivity the analyzer will report an error for the glucose and lactate electrodes.

Correct adaptor

Incorrect adaptor

- Please check your inventory and remove any S4934 Rinse solution bottles from the affected lot
- Please check the Rinse solution bottles installed on your analyzers.
  In case a Rinse solution bottle of the affected lot is installed and the enzyme has been released, then:
  - o Replace the Rinse solution bottle with one from a different lot
  - o Replace the glucose or lactate membrane unit on this analyzer
  - Review glucose and lactate patient results measured while this bottle has been installed as the results may be affected
- Affected Rinse solution bottles may be used on the analyzer until a replacement supply has been received provided that the enzyme is not released
- Once the replacement supply has been received please discard all remaining S4934 Rinse solution bottles from the affected lot in your possession
