Urgent Field Safety Notice

3022

March 2015

IMMULITE[®] 2000
IMMULITE[®] 2000 XPi**Water and Liquid Waste Bottles Issue**

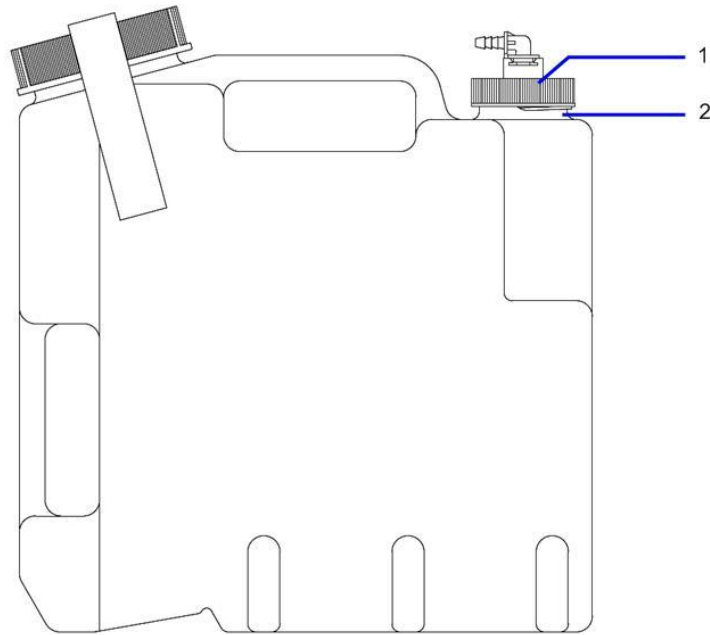
Figure 1. Water Bottle Assembly

Siemens has identified that the water and liquid waste bottle assemblies were manufactured with a quality issue. The smaller diameter opening of both bottles is undersized and/or deformed, preventing the cap from closing or fastening securely to the bottle.

-
- 1 Water bottle cap (38 mm) with an attached aspiration straw
 - 2 Water bottle small diameter opening
-

1. Install the water bottle onto the instrument.
2. Verify that the 38 mm cap is securely fastened onto the water bottle. This will ensure that the aspiration tubing attached to the cap reaches the bottom of the water bottle. Refer to Figure 1.

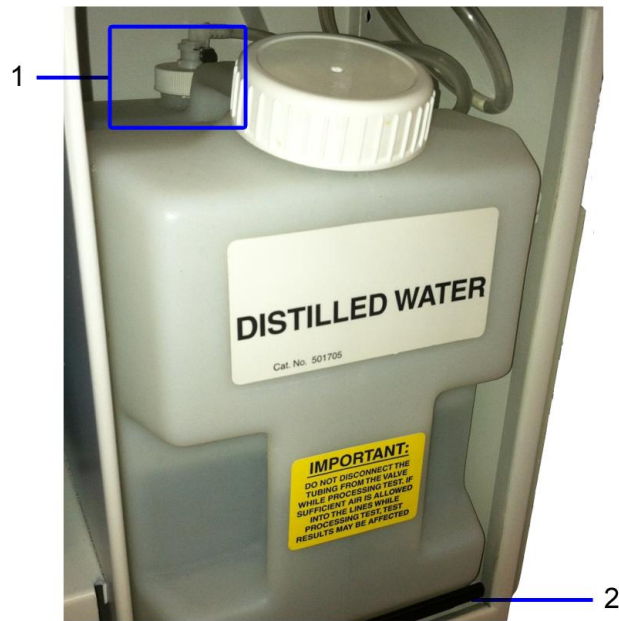
Figure 2. Securely Fastened 38 mm Water Bottle Cap

-
- 1 Water bottle cap (38 mm) securely fastened
 - 2 Water bottle assembly properly seated in compartment
-

4. After refilling is completed and the water bottle placed back onto the instrument, verify that the cap remains securely fastened. Refer to Figure 2.

6. Periodically verify that the 38 mm cap remains securely attached to the water bottle during instrument operation. Refer to Figure 2.
7. If the 38 mm cap is dislodged from the water bottle, perform the following:

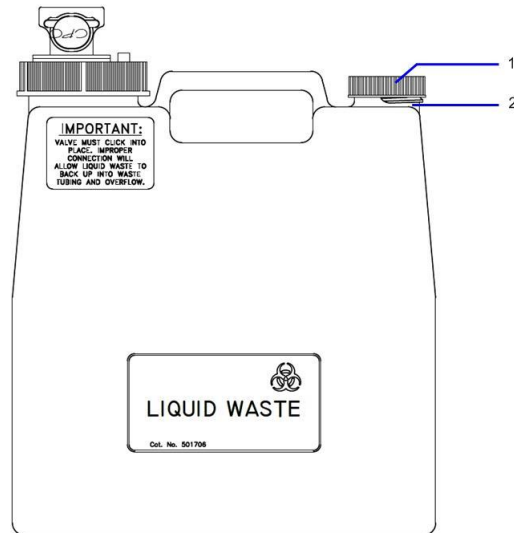
Figure 4. Liquid Waste Bottle Assembly

The small opening is used to pour waste from the bottle. If the cap dislodges during transport of a full bottle, care must be taken to avoid spillage.

-
- 1 Liquid waste bottle cap (38 mm)
 - 2 Liquid waste bottle small diameter opening
-

Ensure when transporting the Liquid Waste Bottle (Figure 4) that you are wearing appropriate Personal Protective Equipment (PPE). There are no other mitigation instructions as a defective liquid waste bottle will not disrupt test processing and there is no potential risk to health as long as you are wearing proper PPE.
