## Urgent Field Safety Notice

### Medtronic DBS Extension Models 37085 and 37086

#### Reinforcement of Device Labelling

Medtronic reference: FA648

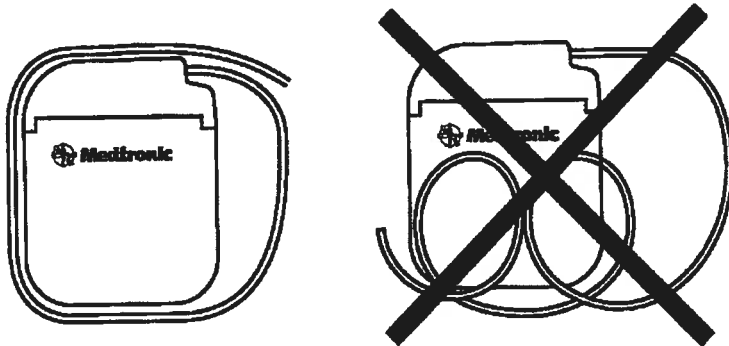
- Ensure that the neurostimulator is placed no deeper than 4 cm (1.5 in) below the skin and is parallel to the skin. If the neurostimulator is too deep or is not parallel to the skin, telemetry may be unsuccessful.
- Do not coil excess extension in front of the neurostimulator. Wrap excess extension around the perimeter (Figure 3) of the neurostimulator to minimize subcutaneous pocket depth, help minimize potential damage during neurostimulator replacement surgery, help minimize potential kinking of the extension, and minimize interference with telemetry. Excess extension should not exceed two wraps around the perimeter of the neurostimulator. Extension lengths requiring more than two wraps can interfere with telemetry.

*Figure 3. Wrap excess extension around the perimeter of the neurostimulator.*
