Urgent Field Safety Notice

33114 Rev. A July 2015

RAPIDPoint® 500 System

Dual LIS Port Invalid Result Transmission

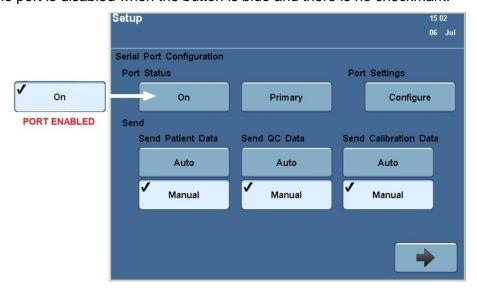
Figure 1. Serial Port Configuration Screen Showing Enabled and Disabled States of the Port

To Disable the Serial Port Connection:

- 1. At the **System** screen, select **Setup**. Enter your password if required.
- Select Printer and Devices > Communications > LIS Communications.
- Select Configure in the Serial column.
- 4. Select **Port Status > On** to disable the Serial port.

The port is disabled when the button is blue and there is no checkmark.

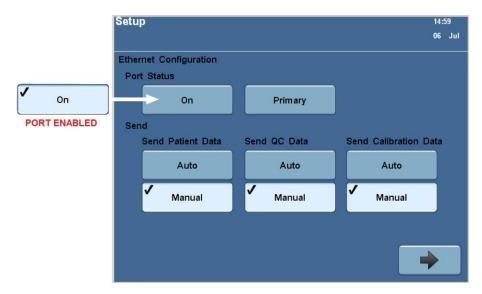
Figure 2. Ethernet Configuration Screen Showing Enabled and Disabled States of the Port

To Disable the Ethernet Port Connection:

- 1. At the **System** screen, select **Setup**. Enter your password if required.
- 2. Select Printer and Devices > Communications > LIS Communications.
- Select Configure in the Ethernet column.
- 4. Select **Port Status > On** to disable the Ethernet port.

The port is disabled when the button is blue and there is no checkmark.
