## Urgent Field Safety Notice

33293 Rev. A

### RAPIDPoint® 500 System

#### Incorrect Sodium Calibrator Value Assignment

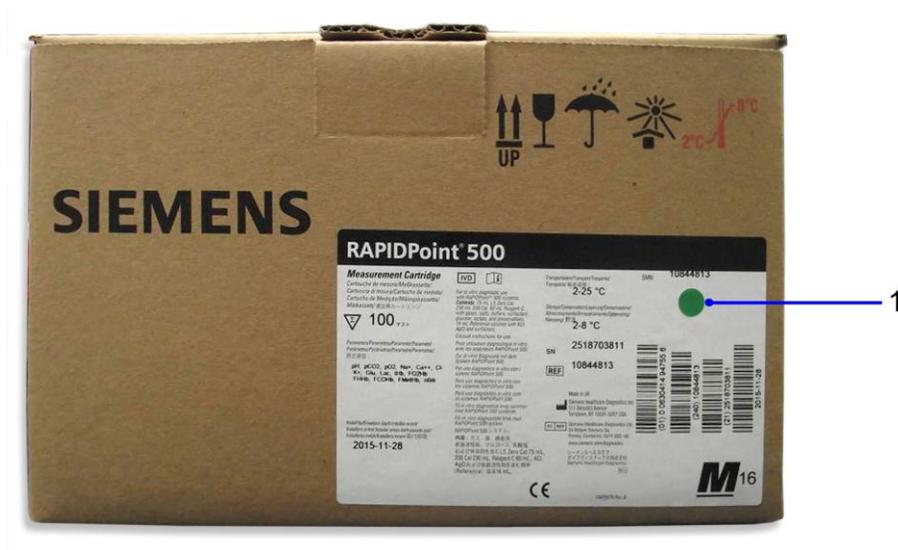
**Figure 1. Green Dot on Exterior Package Label Indicating Acceptable Cartridges**

**NOTE:** Cartridges within the affected serial number range that have a green dot on the box and/or the cartridge are not affected. Please refer to Figures 1 and 2 below.

1 Location of green dot

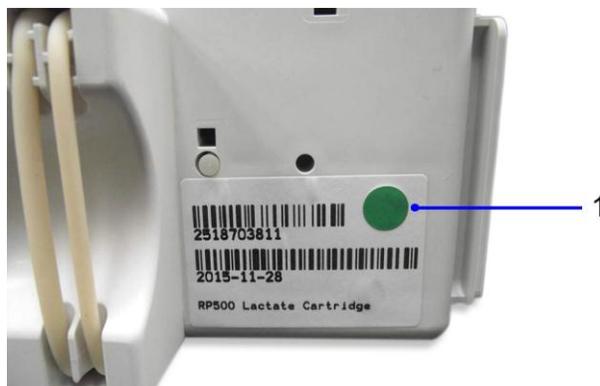
**Figure 2. Green Dot on Cartridge Label at Rear of Cartridge**

1 Location of green dot
