URGENT PRODUCT SAFETY NOTICE

For the NxStage System One S Cyclers Catalog no. NX1000-5 / NX1000-5-A

October 29, 2015

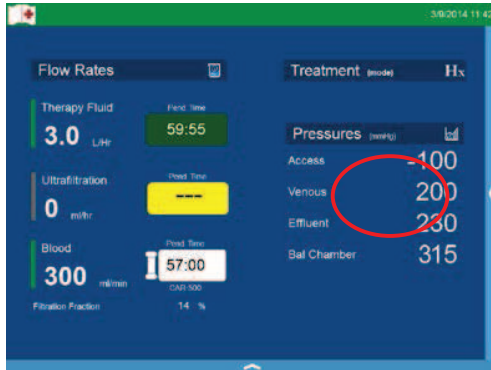
If the UF volume was initially at

and the UF volume has counted down to zero, the UF pump will turn off. NxView will display the UF pump rate as 0. See example below.

A. Disable low fluid temperature monitoring by changing system setting 79 to 0. If a yellow caution 53- Low Fluid Temperature occurs, return the patient's blood and prime a new cartridge to start a new treatment.	
B. When the UF volume setting is set to	Do the following if the software error has occurred

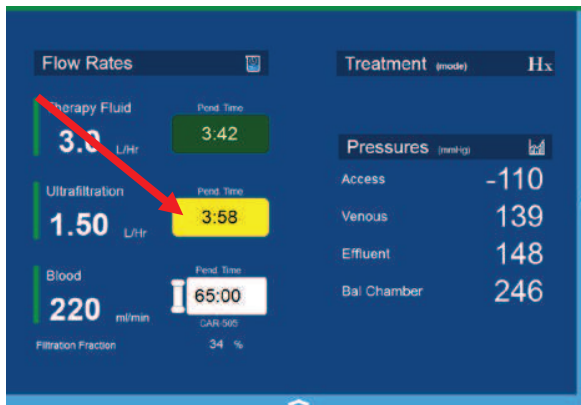
If the UF volume was initially set at a specific target value, the software error has occurred if the UF Pend. Time on the NxView home screen remains the same and does not change at the set pump rate as expected.

<ul style="list-style-type: none"> Manually adjust the UF volume following the attached instructions.
a specific target volume in L.	<ul style="list-style-type: none"> Return the patient's blood. Prime a new cartridge to start a new treatment.
