Urgent Field Safety Notice

SBN-RPD-2015-020

RPD / Point of Care Handheld Platform
Version 3
26-Jan-2016

Handheld Platform – USB Communication Data Loss

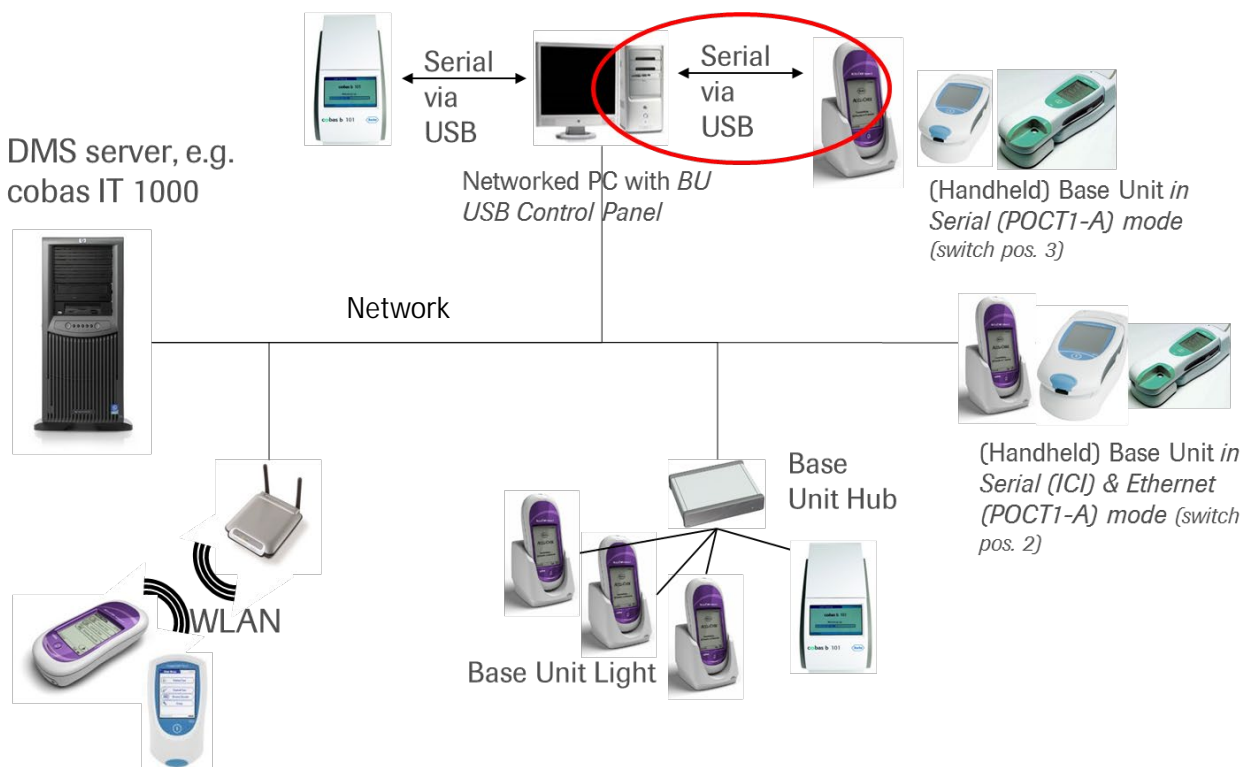
There are various connectivity options for Handheld Platform meters (Accu-Chek Inform II, CoaguChek Professional and cobas h232). Please refer to the graphic below.

Only the connection via USB to a PC is affected by this issue.

Communication via Ethernet (Local Area Network, LAN; Wide Area Network, WAN) or wireless local area network (WLAN) is not affected.

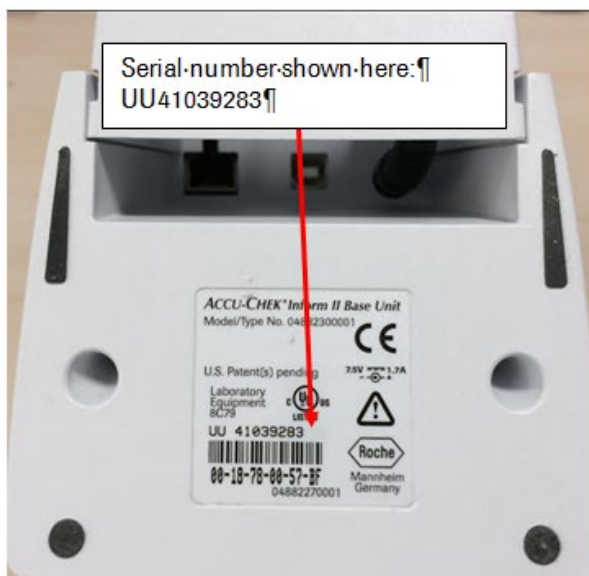
For Accu-Chek Inform II Base Units:

NOTE: You can identify the affected base units by the serial number that can be found on the back label of the Accu-Chek Inform II Base Unit and/or the Handheld Base Unit:
