# URGENT MEDICAL DEVICE CORRECTION MANDATORY SOFTWARE UPDATE IOLMASTER 500

#### IMMEDIATE ACTION REQUIRED

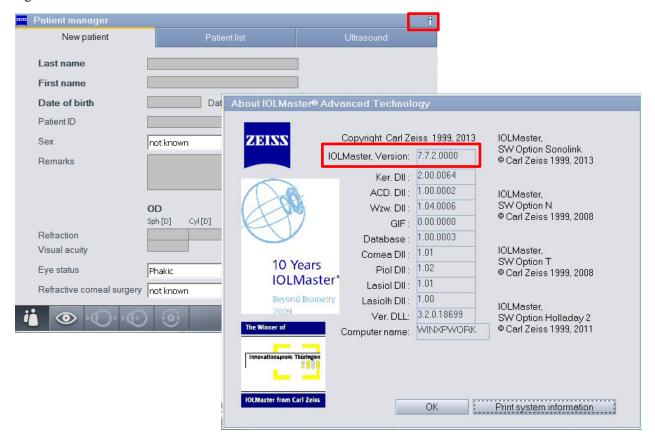
With this letter we would like to inform you about a mandatory software update for your IOLMaster. This applies only to IOLMaster devices with Software Version 7.5.2, 7.7.2 and 7.7. 3. All other versions are not affected.

The Software Version can be checked by pressing on the i-Symbol in the upper right corner of the screen.

To correct the software anomaly it is required that you perform the software update to version 7.5.3 or 7.7.4 using the enclosed USB stick and following the instructions from the attached update instruction.
