To our customers and users of the
Dräger Infinity ACS Workstation Critical Care (Evita Infinity V500)
Dräger Infinity ACS Workstation Neonatal Care (Babylog VN500) and
Dräger Evita V300
with optional PS500 power supply unit

January 2016

Important safety notice!!!
Optional PS500 power supply unit in combination with
Evita Infinity V500, Babylog VN500 or Evita V300
Limited duration of battery supply

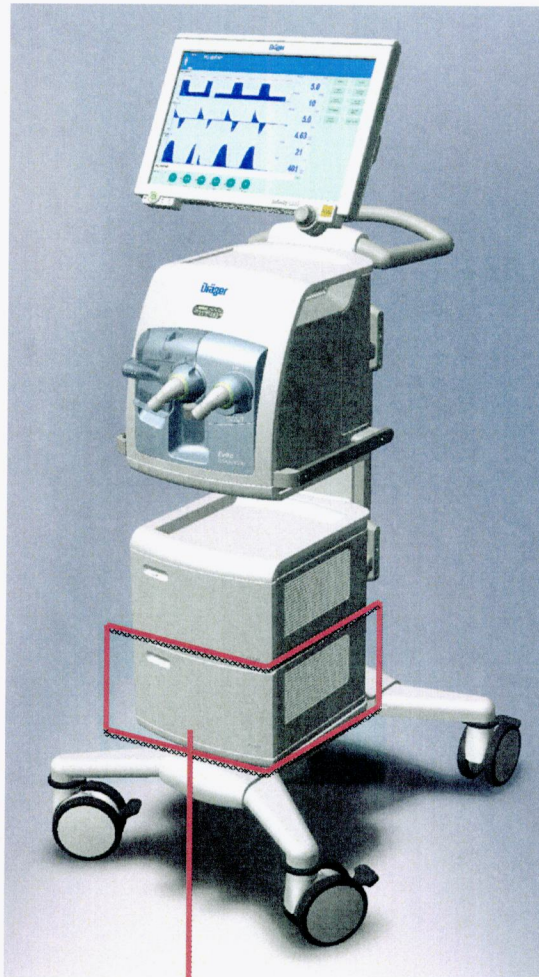
Optional PS500 power supply unit

Illustration of the optional PS500 power supply unit
