### CLINITEK Status®+ Connect Systems

#### Possible Delay in Read Times for Urinalysis Results

#### Reason for Urgent Field Safety Notice

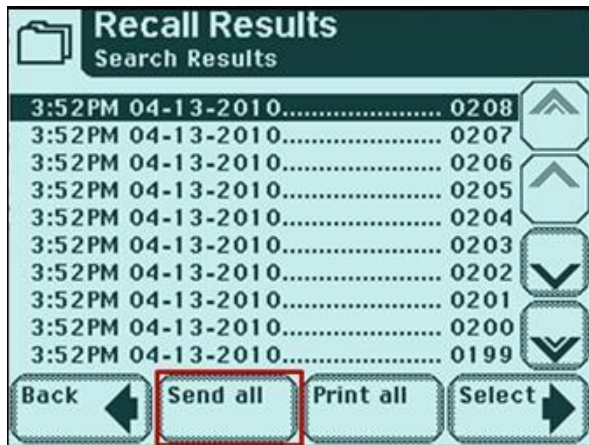
**Figure 1. Location of Send All Button on Recall Results Screen**

In the case that an operator transmits all of the data stored in the instrument to an LIS or data manager by selecting the **Send All** function (Figure 1), the software will allow the operator to perform a urinalysis strip or cassette test while data is still being transferred. In this case, the instrument may be slow to respond. Depending on the amount of data being transferred and the speed at which it is transferred, there may be a delay in timing when the urinalysis reagents are read by the analyzer. This delay in read time can potentially affect patient results.

- Enable “Authorized Operators” on all instruments that are running v2.60/2.4.0.0 or v2.61/2.4.1.0 to ensure the “Send all” feature is not inadvertently used by your institution's regular operators. Refer to “Setting up the Authorized Operators” in the System Configuration section of your *CLINITEK Status+ Operator's Guide* for specific steps on how to set this up.
- Instruct the individuals with administrative rights to the "Instrument Settings" and the "Send all" function on your CLINITEK Status+ Connect system that this function should not be used.
- Complete and return the Field Correction Effectiveness Check Form attached to this letter.
