Urgent Field Safety Notice
SynchroMed® II Implantable Infusion Pump Design Enhancements
Models 8637-20, 8637-40
Device Retrieval

March 2016

Medtronic reference: FA696

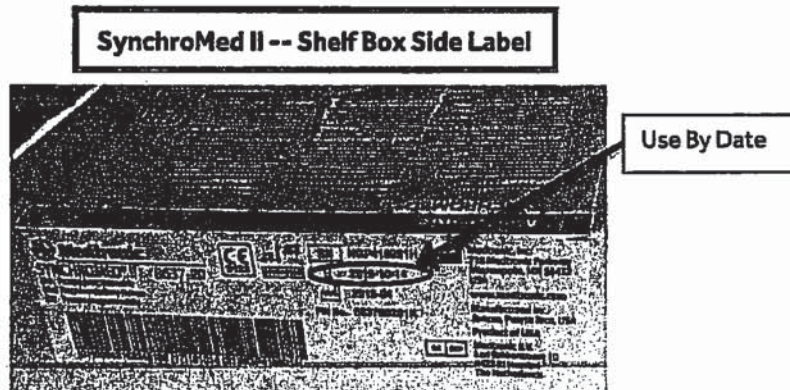
This letter is to inform you that your Medtronic Representative will review your inventory and retrieve any unused SynchroMed II pumps that were manufactured prior to the design changes mentioned above. For your information, SynchroMed II pumps manufactured prior to the design changes can be identified based on Use By date as shown below:

Any pump with a Use By date *on or before* 14/May/2017 was manufactured *prior to* design changes.
