# Urgent Field Safety Notice

## SBN-CPS-2016-007

CPS / Immunology  
Version 1  
26-Apr-2016

### Partly Damaged AssayTips in Certain Lots of AssayTip/AssayCup

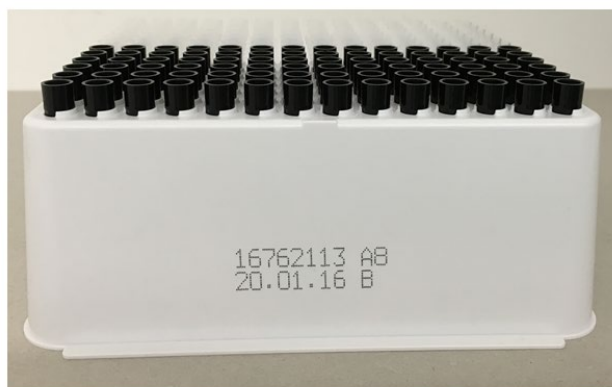
The affected lots can easily identified, see pictures below of the AssayTip/AssayCup tray and package:

- In case if you have any of the affected lots please discard them immediately locally.
