URGENT - FIELD SAFETY NOTICE

ARJOHUNTLEIGH SARA COMBILIZER

Date:	June XX, 2016
Product Issue:	Sara Combilizer tipping hazard
Affected Product:	Sara Combilizer mobilizing aids of model number APA1000-WW, manufactured between 2014-May-16 and 2016-Mar-17
Resolution:	Upgrade Sara Combilizer mobilizing aids with updated design of lock arm and lift yoke.
Affected Serial Nos:	Refer to Attachment A
Field Correction Notice:	FSN/POZ/002-2016
Pages:	3

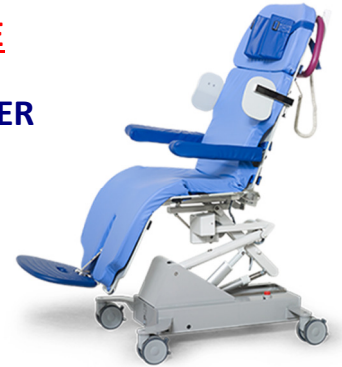
ArjoHuntleigh investigated the issue and concluded that a device tipping hazard may occur on the current Sara Combilizer lifting mechanism, providing a potential for risk to the patient or the caregiver.

The tipping phenomenon has been found during the device testing performed internally; there have been no adverse events or customer complaints on this problem registered to date. The tipping hazard may occur when fully loaded Sara Combilizer in "stretcher mode" is lifted to the highest position (approximately 984 mm \approx 38 3/4") and tilted backwards to the angle of 25°-28°. Although such scenario has been defined as highly unlikely to occur during use with patients, we take this matter seriously and advise you about the further steps.

The problem can be corrected by the device upgrade, which involves the replacement of two parts of the lifting mechanism to ensure the device full stability.
