URGENT – FIELD SAFETY NOTICE

**GETINGE ED-FLOW AER, ED-FLOW SD AER
SOFTWARE UPDATE – Field Action 2016-01**

Date: August 16th, 2016

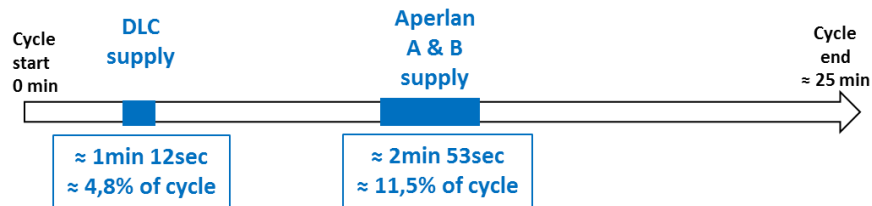
The issue we found can cause a lack of product supply (DLC detergent or Aperlan Poka-Yoke Agent A and Agent B disinfectant) if the compressed air supply of the machine is lost right before or during product supply, and after cycle start, and not re-established before cycle end (periods in blue on timeline).

Duration of reprocessing cycle and product intake in an ED-FLOW or ED-FLOW SD AER

This issue was raised during final testing of an ED-FLOW during the manufacturing process at the factory and we have not received any complaint related to this issue. **From our investigation, it was concluded that the probability of failure occurring is limited to a compressed air supply loss right before or during the product supply phases of the machine (about 4 minutes and 5 seconds).**

This potential for malfunction is caused by a design error in the software source code: the product supply function is wrongly conditioned by air presence. We have developed a new version of the software and removed this wrong condition in the source code. **In version 3.1.0, the product supply function is no longer conditioned by air presence.** The devices involved for your market are all Getinge ED-FLOW AER or ED-FLOW SD AER.
