Attachment 1 to “Measurement Timing Error 7002: 108000572”

D) Identification of the Timing Error:

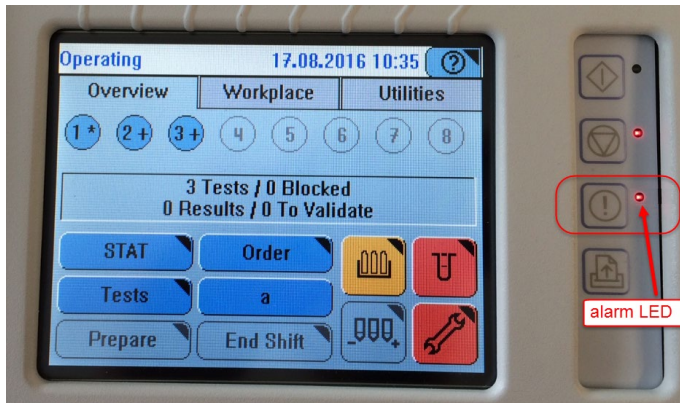
In case the LED shines red / the alarm button on the right hand side of the instrument becomes red (Fig. 1 / 1.1), the operator has to act as described in the respective operator’s manual (section ‘Reacting to alarm messages’).

Fig 1: General overview of the display, global action buttons and LEDs.

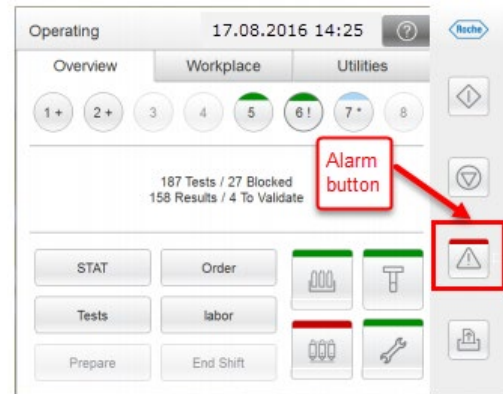
Fig 1.1: General overview of the display and global action buttons.

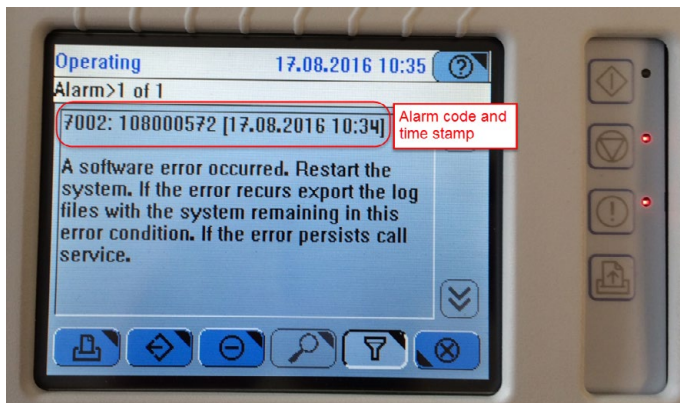
The timing error is indicated by the alarm code “7002: 108000572” incl. its timestamp:

Fig 2: Detailed alarm message on instruments with old screen versions.

Whenever the here reported error “7002: 108000572 A software error occurred” (Fig 2 / 2.1) is listed in the message list the following procedure shall be applied:

1. Review the timestamp of the error message (see Fig 2 / 2.1)
2. Review the samples being processed since that exact time (Fig. 3 and 4 / 3.1 and 4.1)

All samples processed since this time stamp need to be re-measured.

3. Restart the system
4. Re-measure all the tests of respective samples in order to guarantee absence of potentially erroneous results

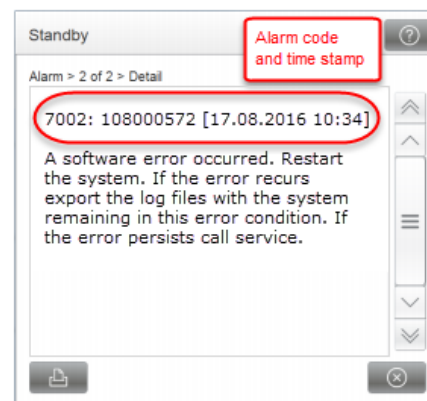
Fig 2.1: Detailed alarm message on instruments with 8.4” displays.

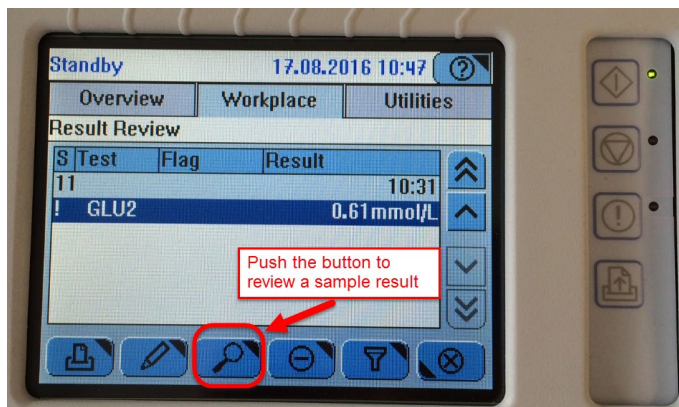
- the time stamp of result generation of sample 11 GLU2 is 10:46
- the error occurred at 10:34
- the result of 0.61 mmol/L for GLU2 might be affected and should be re-tested

Fig 3: Result Review window on instruments with old screen versions.

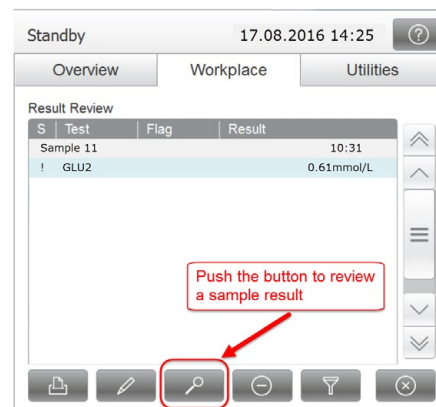
Fig 3.1: Result Review window on instruments with 8.4" displays.

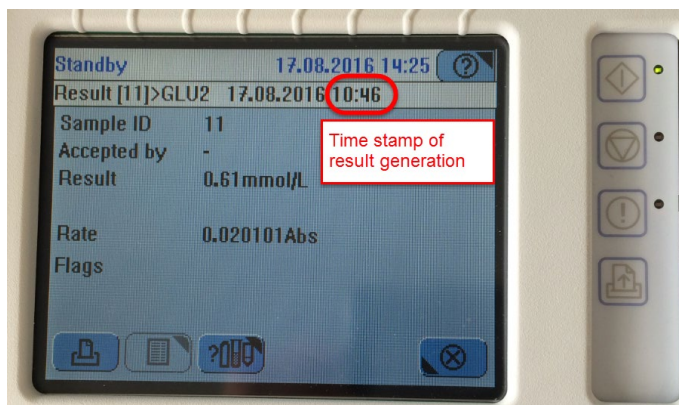
Fig 4: Review the time stamp of a sample result.

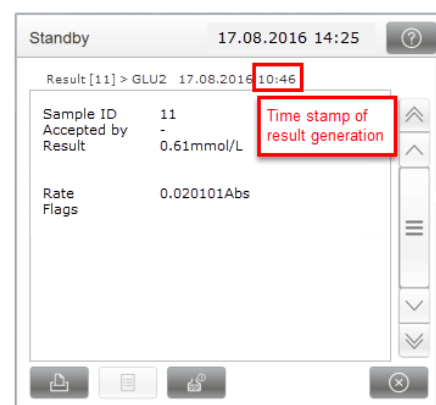
Fig 4.1: Review the time stamp of a sample result on an 8.4" display.
