Internal Reference number: I-00227

Urgent Safety Information

Surgical Technique uCentum™ comprehensive posterior system open and
percutaneous

CS 3801-01 – Locking Screw – All LOTs

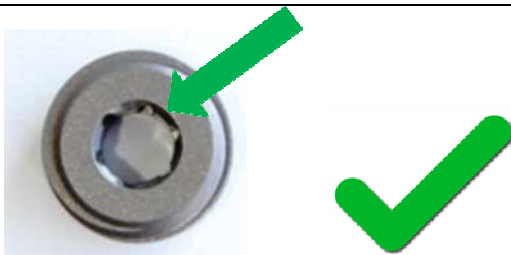
Top side of the locking screw
→ correct insertion, visible inner hexagon

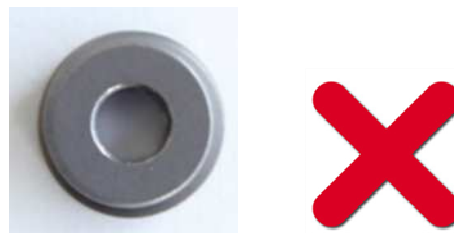
Under side of the locking screw
→ incorrect insert, no visible inner hexagon

As a result of mounting the locking screw from the underside it would not possible to insert and position the locking screw properly into the screw head with the self-retaining screwdriver for locking screws CS 3851-01. In consequence, at the final tightening step of the locking screw with the screwdriver 3851-02 combined with the T-handle torque CS 7146 the screwdriver “spins”, because the screwdriver tip cannot be inserted into the inner hexagon of the locking screw. By this fact latest, the user realizes the false insertion. This situation has to be corrected by a new correct positioning and insertion of the locking screw.

All users have to get knowledge about this safety information to the correct orientation of the locking screw CS 3801-01 together with the screwdriver for locking screws, self-retraining CS 3851-01.

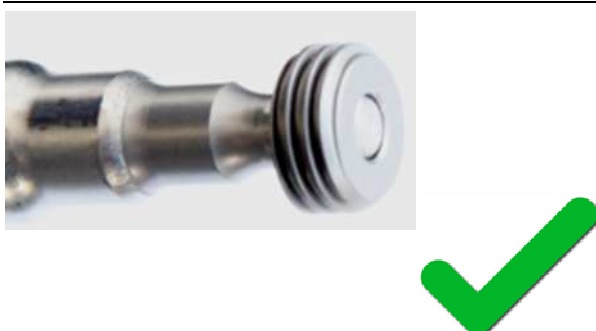
If the locking screw CS 3801-01 is added from the top side with the visible inner hexagon, the locking screw can be mounted on the entire length of the screwdriver tip for locking screws, self-retraining CS 3851-01 (see left figure below). By putting on the locking screw from the underside, the screw can obviously only mounted to a small part on the screw driver tip. (see right figure below).

Adding from the correct side
→ topside

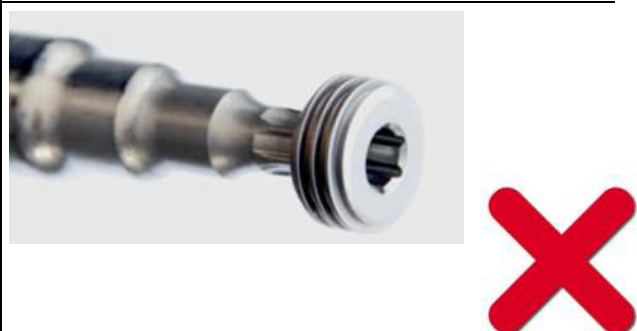
Adding from the incorrect side
→ underside
