URGENT FIELD SAFETY NOTICE

Product Name: **Alaris VP Plus with Guardrails**
Product codes: **9003MED01-G and 9003TIG01-G**
FSCA Identifier: **RA-2016-10-02**
Date: **November 2016**
Type of Action: **Advisory Notice**

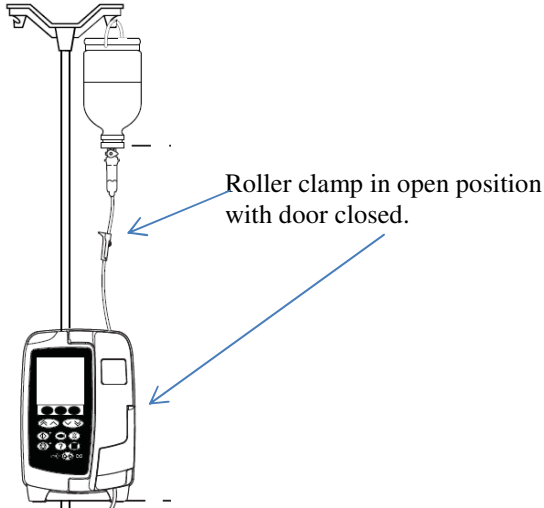
CareFusion has identified a potential risk with the Alaris VP LVP that results in a situation where the upstream occlusion alarm does not generate within the prescribed time period.

1. The Alaris™ VP *plus* Guardrails™ Directions for Use state that upon completion of loading the tubing into the pumping chamber, the user should close the door and open the roller clamp.

Opening the roller clamp once the door is closed will eliminate the potential for an upstream occlusion.
