Urgent Field Safety Notice

Claria MRI™ CRT-D SureScan™ and Amplia MRI™ CRT-D SureScan™

December 2016

Medtronic reference: FA747

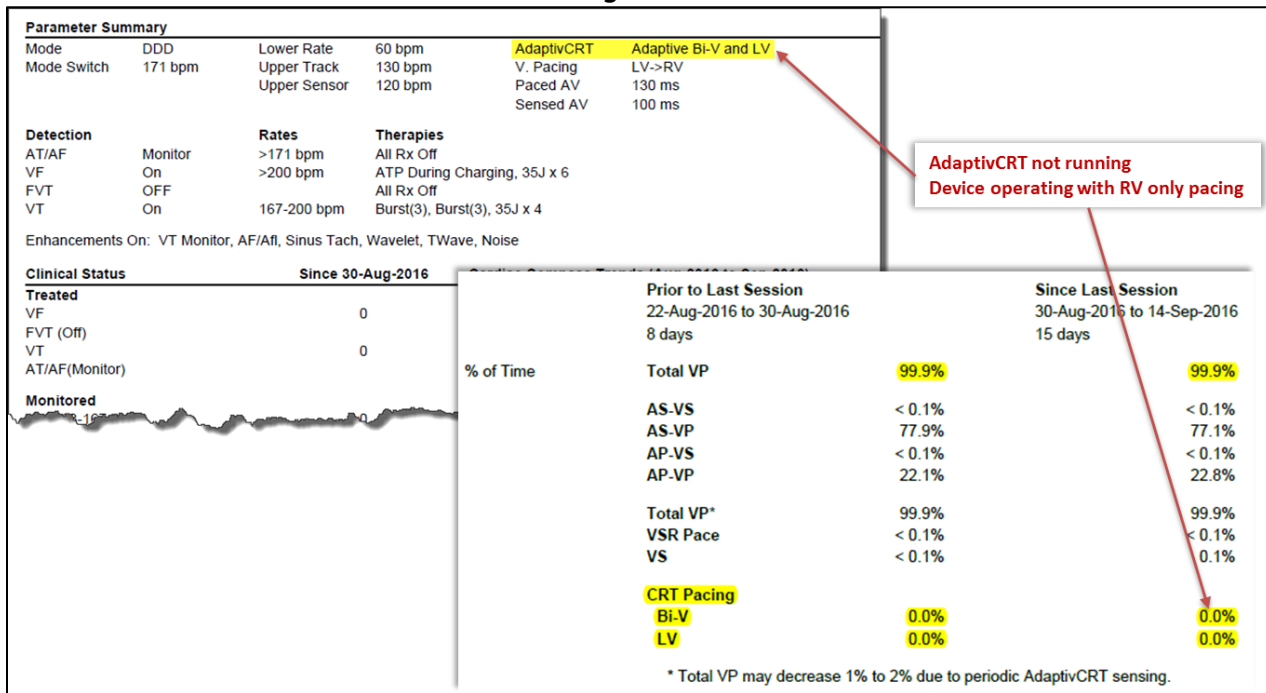
Figure 1

When a patient with AdaptivCRT enabled (shipped setting) is subsequently programmed to MVP mode and then re-programmed back to DDD or DDDR, AdaptivCRT is not re-enabled. When this programming sequence occurs, LV pacing is not delivered, despite parameters indicating AdaptivCRT is enabled (Appendix B, Figure 1). This will result in RV only pacing which may be undesirable for the patient. LV pacing will remain disabled until a specific programming sequence is manually completed; refer to the Patient Management section of this letter (Appendix B) for details.

- If the CRT setting is currently programmed to *Adaptive Bi-V and LV* or *Adaptive Bi-V* (Figure 1), review rate histogram CRT Pacing percentages (CRT Pacing: Bi-V and LV).
- If Bi-V and LV pacing percentages *Since Last Session* are both near 0%, then the device has encountered the programming sequence and has lost LV pacing; proceed to step 2.

- Select the CRT parameter window, select *Nonadaptive CRT*, and select *PROGRAM*.
- Select the CRT parameter window, select the desired AdaptivCRT setting (*Adaptive Bi-V and LV* or *Adaptive Bi-V*), and select *PROGRAM*.
