**To the customers and users of the
emergency breathing devices
Oxylog 3000 and Oxylog 3000 plus**

Important safety information!!!

**Oxylog 3000, Oxylog 3000 plus
Failure of ventilation function with "Control knob faulty" error message**

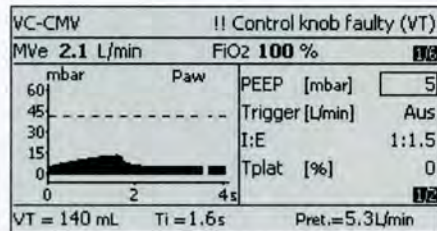
In December 2015 we informed you about an error condition observed in the market with products of the Oxylog 3000 family, where the loss of contact of one of the control knobs generates an error message (previously referred to as "Poti unplugged"). In these cases, acoustical and visual alarms are triggered, the breathing system releases pressure and the ventilation function stops operating. Personal injury was not reported in any of these situations.

Our investigations indicate that the error condition is caused by an oxide layer in the potentiometer. These oxide layers may accumulate over a longer period of time if various factor collude i.e. if the knobs are moved rarely or never. A verified remedy is repeated twisting of the knobs that removes the oxide layer. This recommendation was described in the previous Safety Notice.

Whenever a "Control knob faulty" condition will occur with a device being equipped **with the new software the device will continue to ventilate with the last valid settings**, display for example the values for tidal volume in case of a defective potentiometer for VT and post the corresponding alarm (see Picture below)

However, this particular error condition was still reported from the field after the Safety Notice. The remedy of twisting the knob is still considered effective. Nonetheless, to reduce the impact of this special error condition Dräger has developed a new software that reduces the impact of the error condition.

Software version 1.06 will now be introduced for Oxylog 3000plus, version 1.23 for Oxylog 3000, respectively.

As reflected in the amended IfU you are advised to check patient's condition and the ventilation.

Your local Dräger Service representative or our service partner will contact you to schedule a time to perform the software update.
