## **FIELD SAFETY NOTICE (FSN)**

### **XN-550**

might report wrong measurement results due to improper mixing of a sample only under the combination of the following conditions

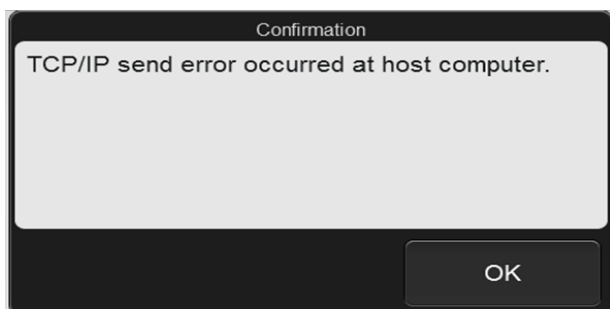
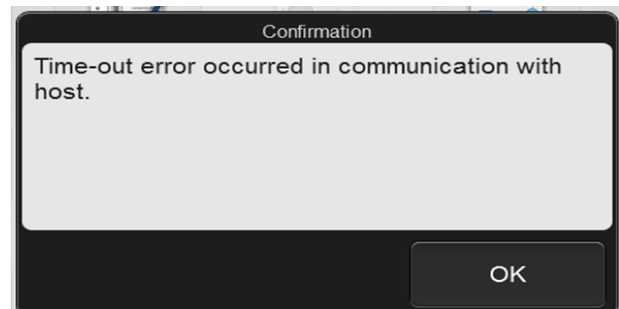
- In case a host communication error appears during XN-550 sampler analysis, it results in an error message and the sampler stops.
- If at that time a sample tube is located in the sample tube holder, it will not be processed until the error is accepted. The time between appearance and acceptance of the error can vary depending on the attendance of the analyser. During this time sedimentation of the blood sample will occur.
- After accepting the error the sample tube might be processed without additional mixing, which could lead to potentially wrong measurement results due to blood cell sedimentation.

Examples of possible error messages of the XN-550 which would indicate erroneous communication with the host.

In case an error message related to host communication and/ or TCP/IP connection appears during an XN-550 sampler run due to a host communication failure, it is MANDATORY to check the sample tube holder and remove the sample tube, if possible, BEFORE accepting the error and restarting the sampler. In case the sample tube holder is not accessible, accept the error message and do NOT use the measurement result from this particular measurement. Make sure the sample is re-analysed. Otherwise there is a risk for aspiration without prior mixing, leading to wrong measurement results.
