Urgent Field Safety Notice

SBN-CPS-2017-015

cobas c 501/502 operator injury on USM cover 3

Product Name	cobas c 501 module cobas c 502 module
Affected Instrument Part GMMI / Part No	USM cover 3 GMMI 05400937001
Instrument/System Affected	cobas c 501 module (GMMI 04745914001) cobas c 502 module (GMMI 05964067001)
SW Version	Not related to the software version
Type of Action	Field Safety Corrective Action (FSCA)

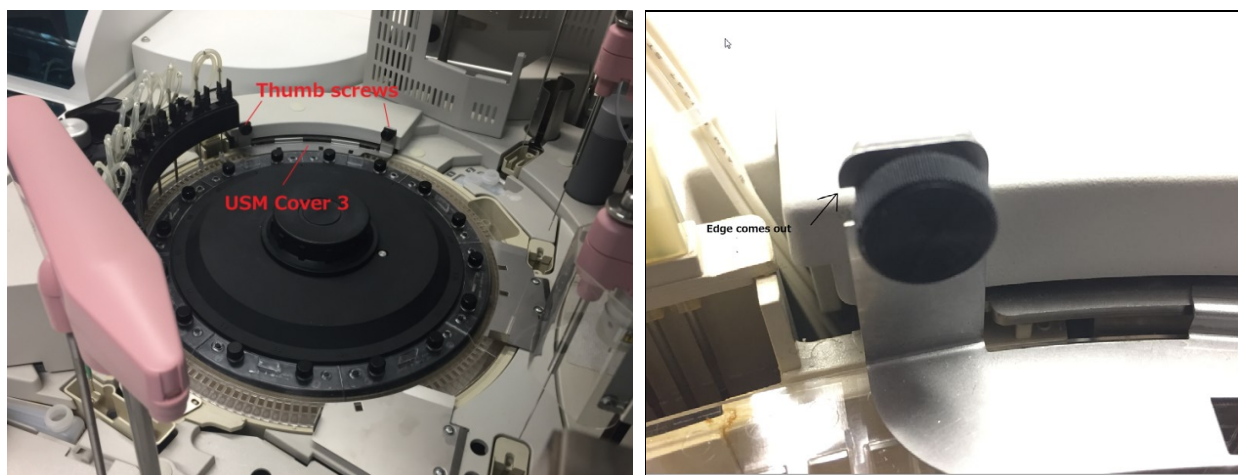
1. The operator was performing monthly maintenance to clean the incubation bath and replace cuvettes on a **cobas c** 502 module.
2. As a preparation step, thumb screws were being loosened to remove the USM cover 3, as illustrated below.
3. When the operator gripped the left thumb screw and tried to loosen it, she felt pain on her left thumb and found that it was already bleeding.
4. Her thumb was injured by the 90 degree-edge of the USM Cover 3, which is shown on the following picture.

Although the sharp edge of the USM Cover 3 is clearly visible, a medical risk due to an injury cannot be excluded.

Customers are advised not to overtighten the thumb screws when replacing the cover after maintenance. When removing the screws for maintenance **avoid** touching the edge of the USM Cover 3.
