## Urgent Field Safety Notice

CC 17-18.B.OUS

### ADVIA Centaur® XPT

Follow-Up: Mitigation Identified for:  
ADVIA Centaur XPT - T3 Kit Lots Ending in 198 System Error

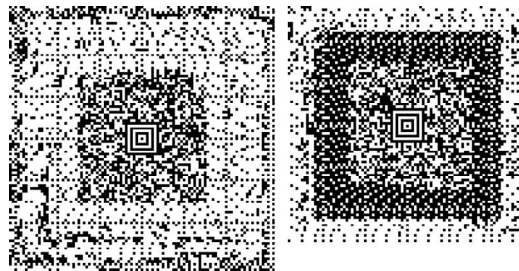
Test Definition, revision 1.8 (for ADVIA Centaur XPT):

Siemens has completed the investigation and determined that the issue is caused by an error in the ADVIA Centaur XPT 2D barcode on the Master Curve Card (MCC) associated with T3 lots listed in Table 1.

- To implement T3 kit lots listed in Table 1 on your ADVIA Centaur XPT system, it is important that you perform the following steps, **in the order specified below**, to avoid an un-recoverable system error:
  1. Scan the corrected T3 Test Definition 2D barcode below onto your ADVIA Centaur XPT system. This will update the T3 Test Definition to revision 1.8.

- Select the Test Definition tab
    - Select T3
    - Verify that the “Test Version” is 1.8
  3. Scan the 2D barcode on the MCC included with the ADVIA Centaur T3 kit lots listed in Table 1. This will successfully install the lot specific parameters required to run kit lots listed in Table 1. By scanning the barcode above in step 1, the system will have the T3 Test Definition revision 1.8. The Test Definition contained in the 2D barcode on the MCC (revision 1.7) will not be installed on the system by the software as it is an older version, thus avoiding the un-recoverable system error.
