Urgent Field Safety Notice

Commercial name/Model: *BeneFusion VP1, BeneFusion VP3 infusion pump*

FSCA-identifier: *JXXY-20170717*

Type of action: *Safety Notice and Device Exchange*

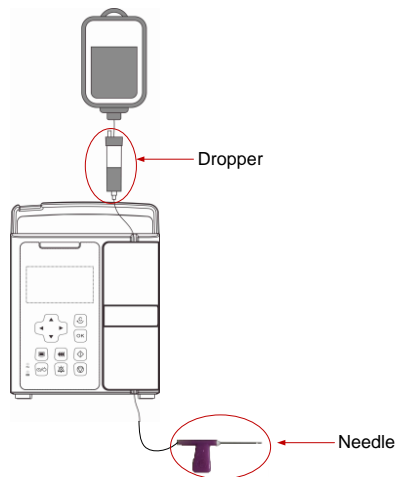
Rate Abnormality Screening Method

- 1). Fully prime the administration set with liquid;
 - 2). Load the administration set into the BeneFusion infusion pump and close the door;
 - 3). Open the Robert clamp and flow rate regulator of the set;

- 4). Observe the dropper or needle for 30 seconds:
 - a) If any drop drips or increases gradually, then the flow rate is abnormal, pump should be removed from clinical use and quarantined.

- b) If NO drop drips or increases gradually was observed, then the infusion pump could be used normally for this infusion.
