Urgent Field Safety Notice **Perfusion Tubing System Packs**

Date: October 05, 2017

Reference: CP-MIR-2017-001

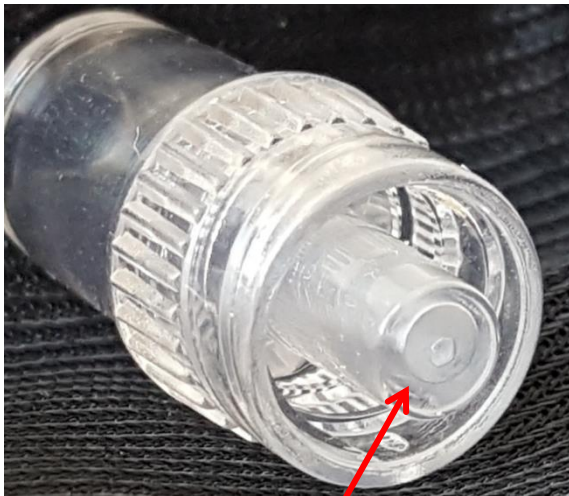
Complaints of difficulties draining fluid on lines included in the PTS have been reported. In all cases, partial occlusions of the luer connector were noted by customers. Investigation determined that the reported connector occlusion was generated during molding of one specific lot of luer.

NOT CONFORMING

1. Open the connection or remove the protection cap from male luer connectors.
2. Visually inspect male luer connectors for occlusion. Refer to the pictures below to determine conformity of the luer.
3. Restore connection as needed.
4. If a non-conforming luer is identified or in case of doubt, replace the PTS with a new one and contact LivaNova.

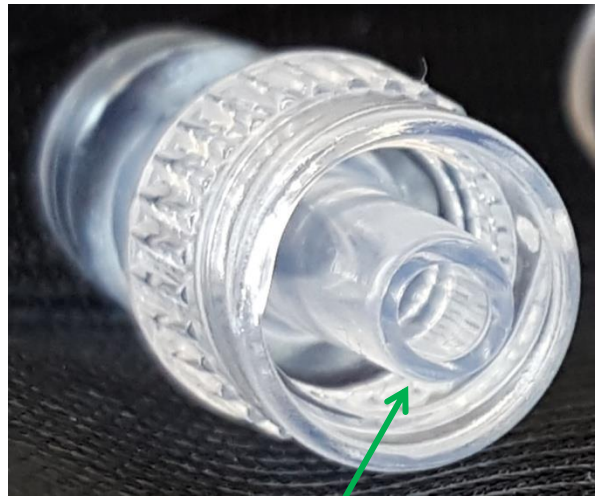
CONFORMING
