URGENT - FIELD SAFETY NOTICE

**MAQUET *HLX 2004-5 DF, HLX 3004-5 DF and XTEN DF*
Field Action *MSA/2017/002/IU***

Product Issue: Breaking of AC2000 spring arms in use with HLX2004-5 DF, HLX 3004-5 DF and XTEN DF cupolas .

Field Correction Notice: **MSA/2017/002/IU**

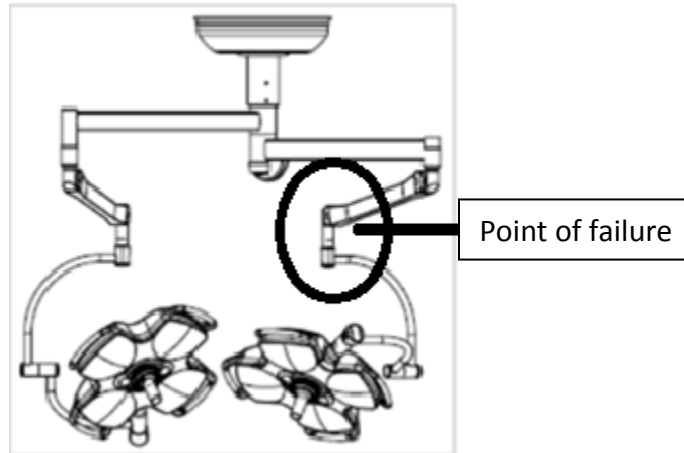
From our investigation it was concluded that there is a low failure rate that only can present itself on the devices of types and production identified in this letter. The issue relates to a crack in the metal of the spring arms that has the potential develop into a break. The devices are over ten years old and even so

This potential for malfunction is caused by fissures near the weld seam at the front pivot of the spring arm. The design of the spring arm was improved in 2006. The devices involved for your market are limited to those listed in the attached Consignee list.

Resolution: MAQUET proposes to replace the affected spring arms with new ones to make sure all devices present in the market are working effectively and safely.

This letter is to inform you of a corrective action that consists of replacing all potentially affected spring arms still in use with new ones. This action will be performed to prevent any possible hazard to persons and equipment.
