URGENT PRODUCT SAFETY INFORMATION / PRODUCT RECALL

2M insert 15° for MUTARS® RS cup and LUMiC® TiN

Our Reference No.: FSCA_17002

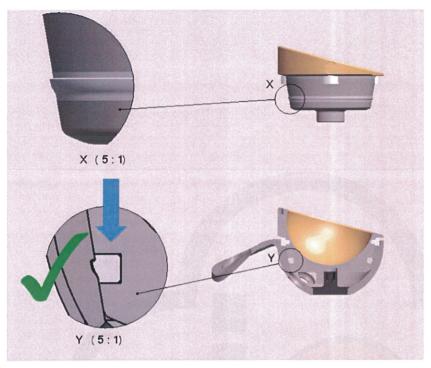
Figure 1: 2M Inlay 15 ° with PE retaining ring

Figure 1 shows a 2M Inlay 15 ° with PE retaining ring.

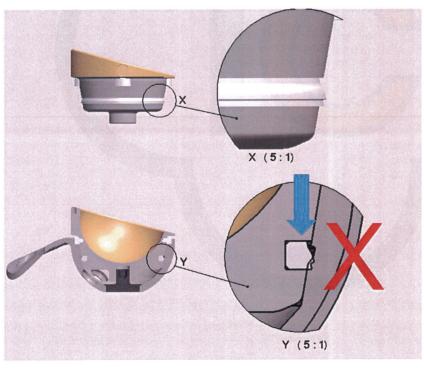
Figure 2:

The PE retaining ring has a top and a bottom side to it. If the ring is mounted correctly, a snapon lip snaps into a notch in the hip cup to ensure correct and secure positioning of the inlay in the hip cup (see Fig. 2).

Correct mounting:

The <u>upper</u> part of the figure shows the snap-on lip of the 2M Inlay 15°, zoomed in on the left. The nib of the latch lip points upwards.

In the <u>lower</u> part of the figure, the proper fit of the inlay in a hip cup can be seen (right). The enlargement of the detail shows the latch lip pointing upwards (left).
