Date: 19 March 2018

URGENT FIELD SAFETY NOTICE:
Epoca Stem Extractors and Connection Screws
1124235 – Field Safety Notification

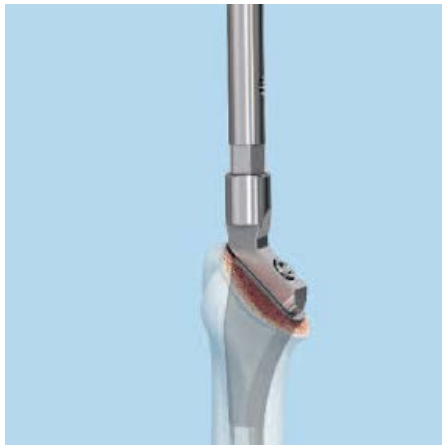
P/N 03.401.072 Stem Extractor, for Guide Bar (03.401.070)
used with 355.250

There is a potential for the Connection Screw (P/N 03.401.077) of the Stem Extractor (P/N 03.401.072) to break. This breakage could occur during the step 3 “Head/eccenter removal and humeral stem extraction” shown and described on page 10 of the Surgical Technique “Epoca Revision Set” [DSEM/TRM/0714/0131(1)].

If the Stem Extractor breaks, the potential impact to the patient includes surgical delay, bone damage, and/or adverse tissue reaction.

In the event the connecting screw for the stem extractor breaks there are additional known methods available to provide the best chance to complete the removal of the Epoca stem. The standard methods listed below are often necessary even when the stem extractor remains functional.

- Carefully sliding a thin osteotome from proximal to distal adjacent to the stem to loosen the stem.
- Longitudinal corticotomy(s) can be done sequentially to create a loosening effect along the stem in the proximal humeral canal.
- The two above steps can be aided by use of grasping the proximal stem with vice grips that enable longitudinal axial extraction loads to be applied.
- Finally, if these methods fail, a distal humeral cortical window can be made to drive the implant out proximally by impacting the stem distal tip distal to proximal.
- The instrumentation required for these methods include (but is not limited to): ultrasonic bone cement melting, a variety of straight, curved and flexible chisels and osteotomes, gouges, curettes, elongated hooks, vice grips, and a variety of curved and straight tamps.
