# Field Safety Notice

**FSCA Identifier** FSN2018040XX

**Type of Action** Immediate Product Recall

**Affected Devices** NovaLine® Tubing Sets for Hemodialysis

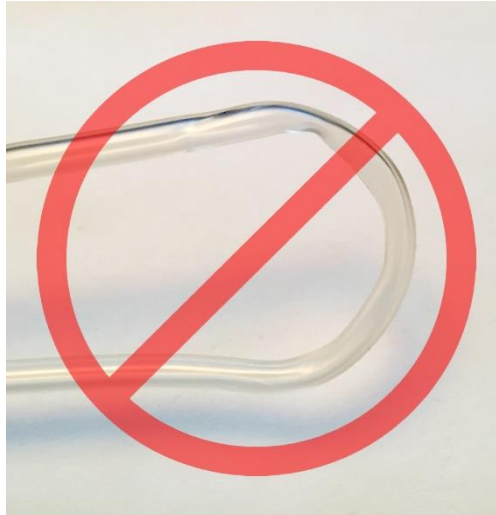
**Problems 2 Description** An exceptionally rare event of kinking of the blood pump segment

Cause: This might be caused by the worker's improper tubing placing and the inspector fails to pick it out during 100% final product inspection and sampling inspection.

Potential Risk: Hemolysis

Operator must check the presence of kinking all along the bloodline before use. In case the operator recognizes the presence of kinking, the tubings must be scrapped.

Re-train the workers on tubing rolling process as well as workers on 100% final inspection of finished products

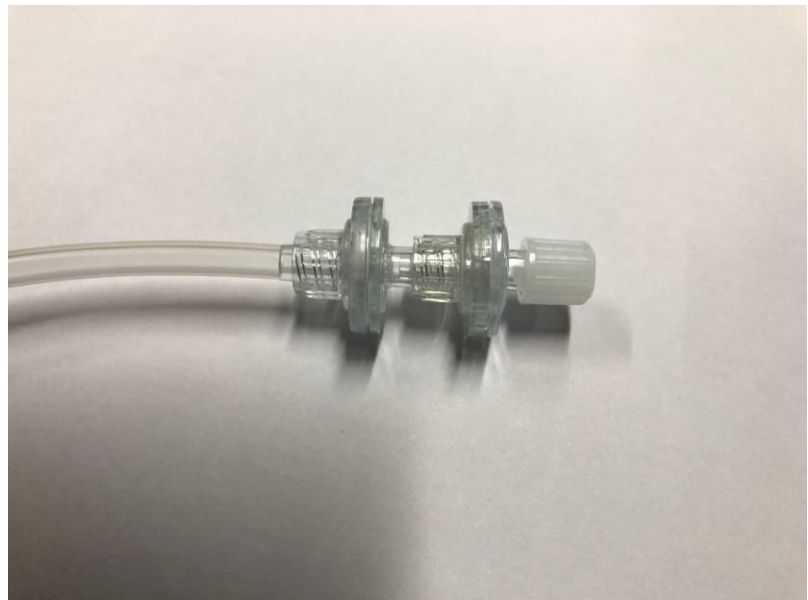
**Problems 4 Description** Rare events of air entrance in the extracorporeal blood circuit. Majority parts of the events involve the transducer protector. The first TP was glued to the tubing and the second TP was screwed to the first TP manually. The second TP might not be firmly connected.

Cause: Improper operation of the worker. Components may not be tightly screwed during production and become loose after transportation. If the connection is not tightened by operator according to section 5.4 of the manual, air entrance may occur.

Potential Risk: Clotting

**Action to be Taken by Customers / Users** Operator must check the tightening of all the bloodlines connection before use according to section 5.4 of relevant product *Instructions for Use*. The critical connection to check is illustrated below:

**Actions Planned by Vital Healthcare** The double TP should be glued to ensure they're leak-proof and reduce the risk
