Important safety information for customers regarding a field corrective action:
AX015/18/S

Important safety information for customers regarding a field corrective action: ARTIS pheno systems

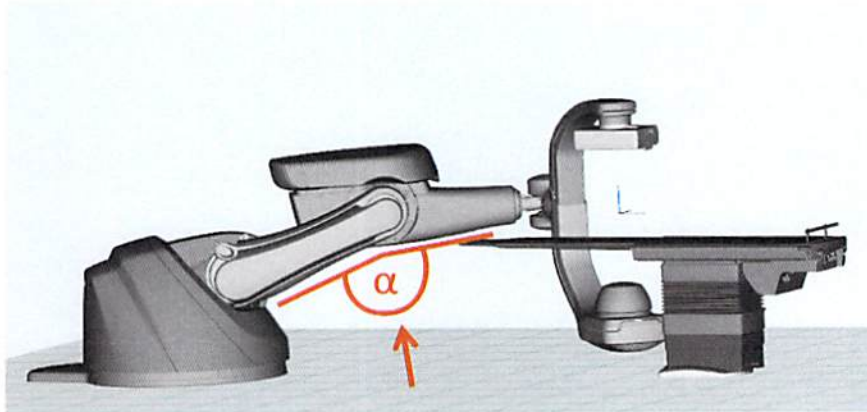
Figure 1: Depiction of C-arm in a fully extended longitudinal position

If the C-arm is moved manually longitudinal to a fully extended position it may occur rarely, that the system's safety stop mechanism may be activated.

As a result, the C-arm of ARTIS pheno stops the movement and can drop up to 20 mm (0.8"). This can happen during an ongoing procedure.

A fully extended longitudinal position is reached when the stand arms are almost completely stretched out. In this case the angle α between these arms becomes maximal, as can be seen in the figure above. Angular values of α greater than 170 degrees shall be avoided.

As an immediate measure, the operator shall avoid to drive the C-arm into a fully extended longitudinal position.

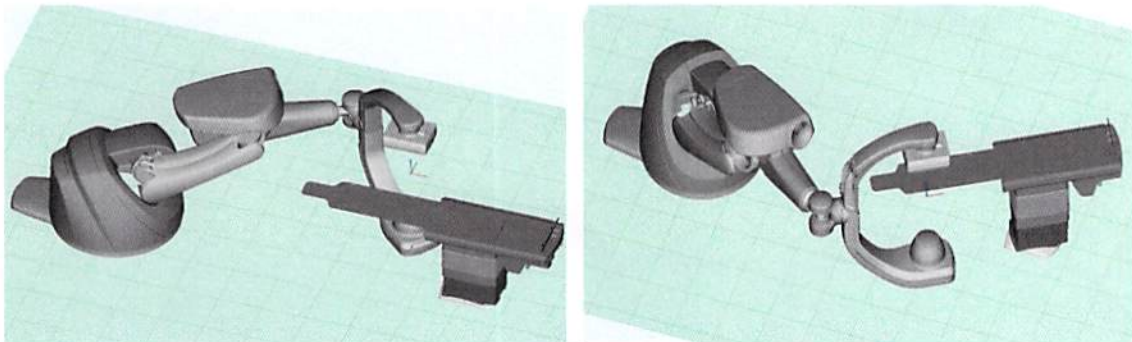
Figure 2: Exemplary depiction of two fully extended C-arm positions

To illustrate this further, Figure 2 shows two examples of system positions with a fully extended longitudinal C-arm, which shall be avoided.
