21st June 2018

This letter is to inform you of an issue with a subset of the first generation WiSE CRT Model 4000 Transmitters that can result in premature depletion of the battery due to current leakage at the termination of the battery cable to the transmitter housing. As of the date of this letter, six returned devices have been confirmed to be affected by this.

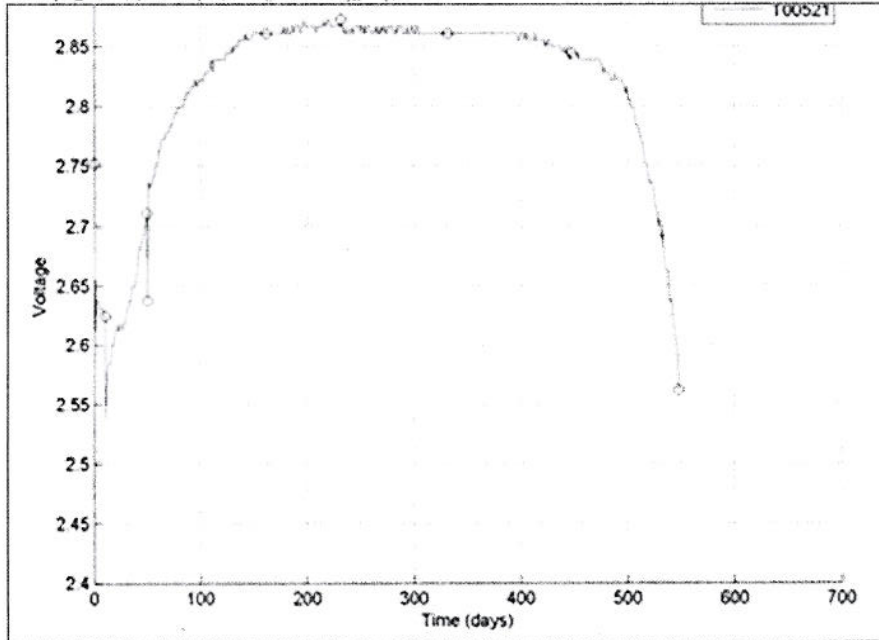
Example of a normal battery curve:

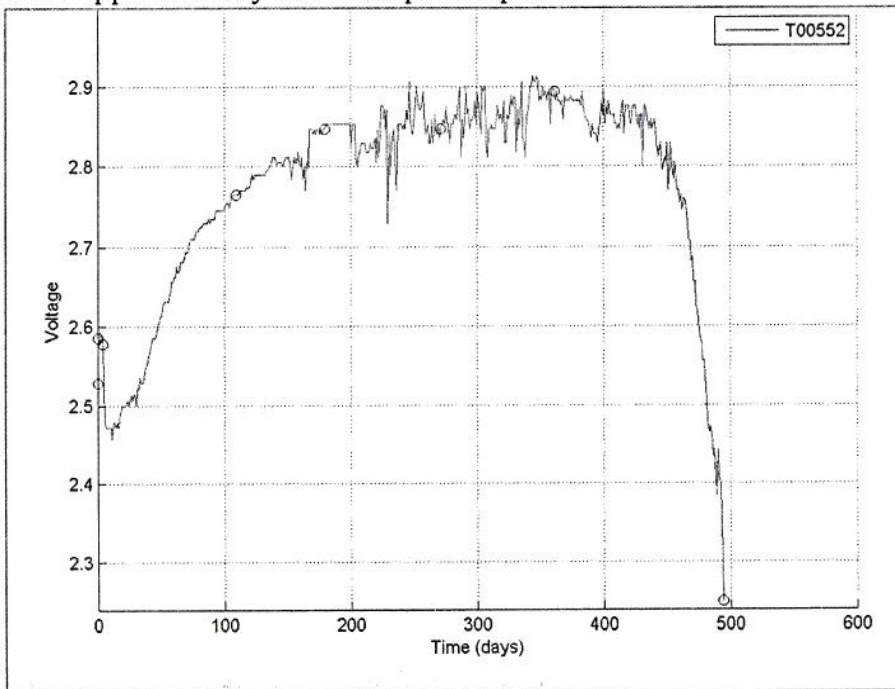
The current leakage initially presents as an erratic battery curve with a sudden onset. Analysis of returned units to date has demonstrated this onset occurred at 4 to 9 months post implant. Refer to Appendix B for an example of typical and atypical battery curves. Because the current leakage draws energy from the battery, this particular mechanism of failure is also associated with a significant gap between predicted and actual longevity of the battery, by up to 60% reduction in capacity. Please note other factors can cause temporary changes in current drain including intermittent pacing and rapid fluctuations in the pacing rate.

Engineering analysis on the six returned units demonstrate a loss of electrical isolation of the positive battery wire due to moisture intrusion at the junction between the cable and transmitter housing. This presence of moisture, in this area, initiated current leakage between the positive battery wire and battery ground, which prematurely depleted their connected batteries.

Example of a battery curve with current leakage. Note sudden onset of erratic battery curve approximately 6-months post implant.

Patients should be followed up at one-month intervals. Remaining battery life should be based upon battery voltage rather than the longevity calculation. The elective replacement indicator (ERI) occurs at 2.65V; with end of service (EOS) at 2.1V. It is recommended that the transmitter should be replaced (with a Model 4100 Transmitter) at the next battery replacement.
