Urgent: Field Safety Notice / FSCA 004-18

Product name	Reference number	Versions
IH-Com Fullversion	009000	5.1.7 and 5.1.10
IH-Com for Reader	009010

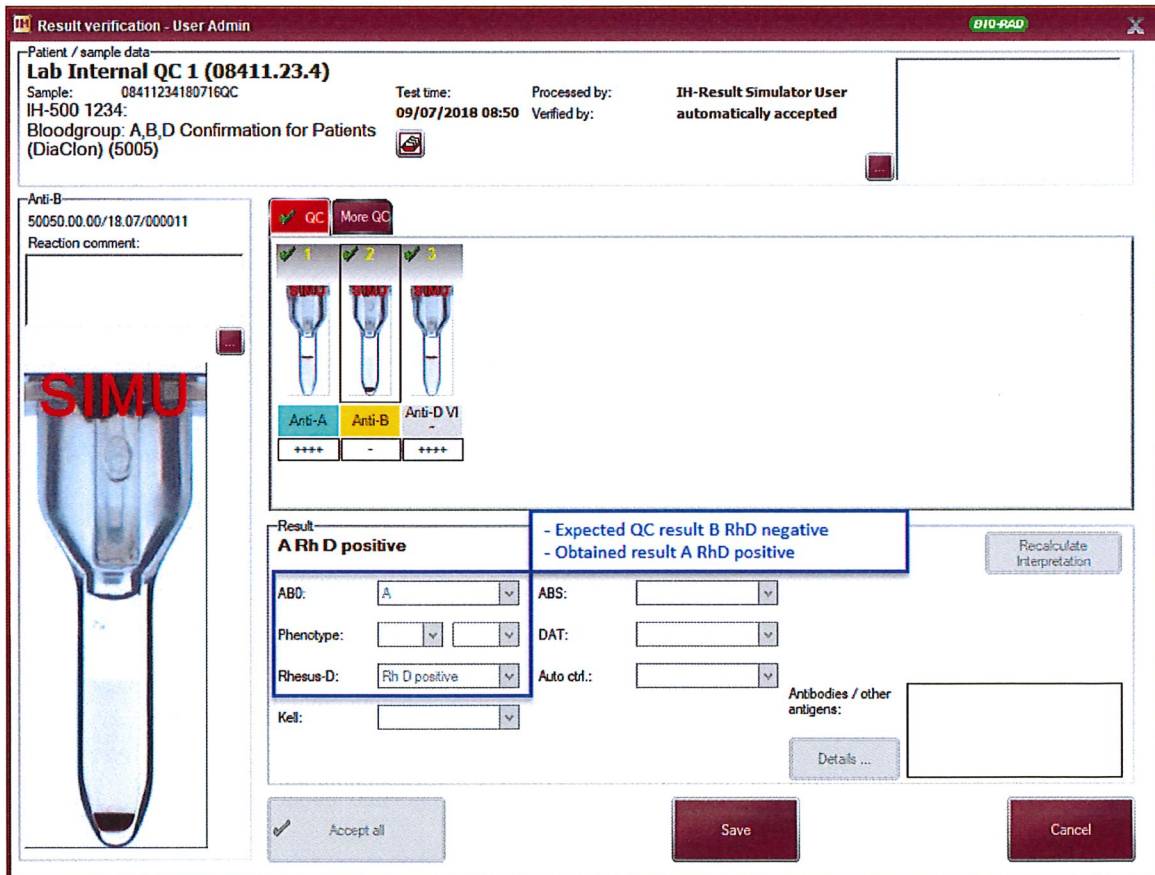
Figure 1: ABO forward example in IH-Com result verification.

A problem occurs during the test of this QC sample, the obtained result is A Rh positive whereas the expected result is B Rh negative and this QC was accepted by IH-Com ("QC pass" shown below (1))

Based on the transfusion guidelines used in most laboratories, in case of a reagent or instrument failure not detected by the routine QC, a risk remains.

This anomaly will be definitively corrected by installing a service pack which will be released beginning of Q4 2018.
