**Aptio® Automation StreamLAB® Automation**

**Some modules missing pacemaker warning labels**

This response form is to confirm receipt of the enclosed Siemens Healthcare Diagnostics, Urgent Field Safety Notice LAI18-04.A.US dated August 2018 – Some modules missing pacemaker warning labels. Please read each question and indicate the appropriate answer.

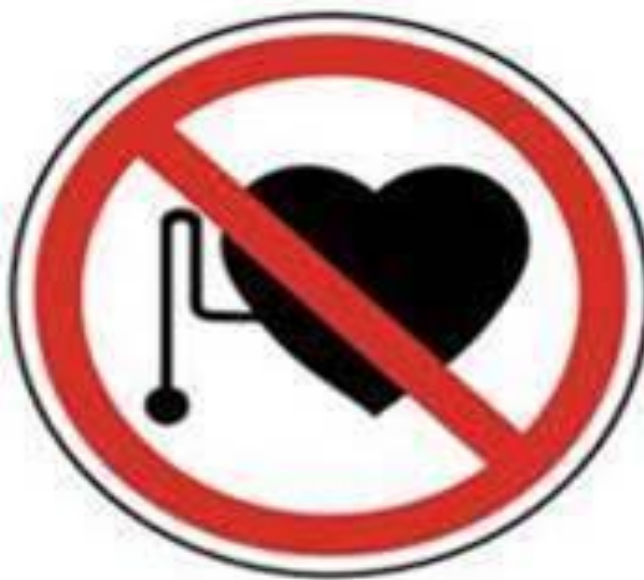
- In the modules listed in Table 1 and 2, the transport mechanism that moves the robot along the axes, generates a magnetic field which may interfere with pacemaker functionality at close distances.
- The pacemaker safety label shown below indicates the potential risk of interference to pacemaker functionality. On some modules, this label may be missing.

Tape this sheet to any module listed in Table 1 or Table 2 that is missing a warning label:

1. Personnel fitted with a pacemaker must not be at distances less than 200 mm (7.87 inches) of the modules axes (transport mechanisms) for the modules listed in Table 1 and Table 2 even if the warning label is missing.
2. Verify that the modules listed in Table 1 and 2 all have a pacemaker safety label attached either on the cover or inside the cover of the module. If there is no safety label on the module,

please remove the last page of this letter and tape a copy of the safety label to the cover of the module until an official Siemens product label is available.
