Urgent Field Safety Notice Product Correction

This Product Correction letter is to inform you of an issue with the ARCHITECT c Systems Mixer (LN 09D59-01, 09D59-02, and 09D59-03). There is the potential for the mixer blade, attached to the mixer with a screw and nut, to separate from the mixer. The missing mixer blade will result in inadequate mixing of the reaction mixtures leading to potential incorrect results (failed assay calibration, Quality Control (QC) out of range, and/or incorrect patient results). The impact on the test result may vary depending on the assay being performed and the viscosity of the patient sample.

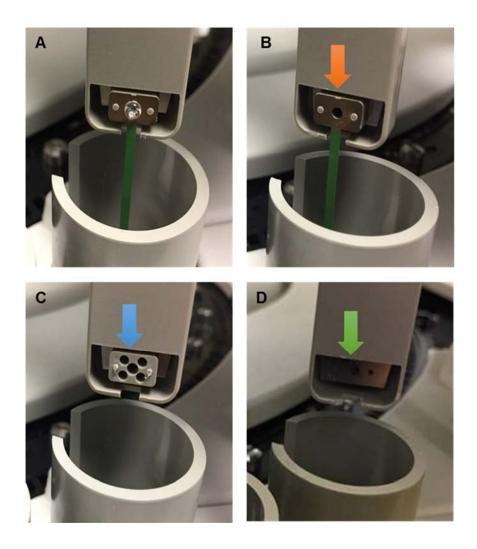
The following pictures show a A) normal mixer B) mixer missing the mixer screw (orange arrow pointing to missing screw), C) missing mixer blade with spacer shim present (blue arrow pointing to missing mixer blade), and D) missing mixer and spacer (green arrow pointing to missing mixer blade and spacer).

- 1. Replace broken mixer. Refer to Replace the Mixer (c4000, c8000, c16000)1.
- 2. Replace the cuvette dry tip. Refer to Replace the cuvette dry tip (c4000, c8000, c16000)1.
- 3. Follow the instructions in **Appendix C** to inspect all cuvettes to ensure that the screw or nut did not fall into an individual cuvette.
