**URGENT: FIELD SAFETY NOTICE – MMS-19-1572**

T34™ and T34L™ (T60™) Ambulatory Syringe Pumps

Type of Action: Advisory Notice

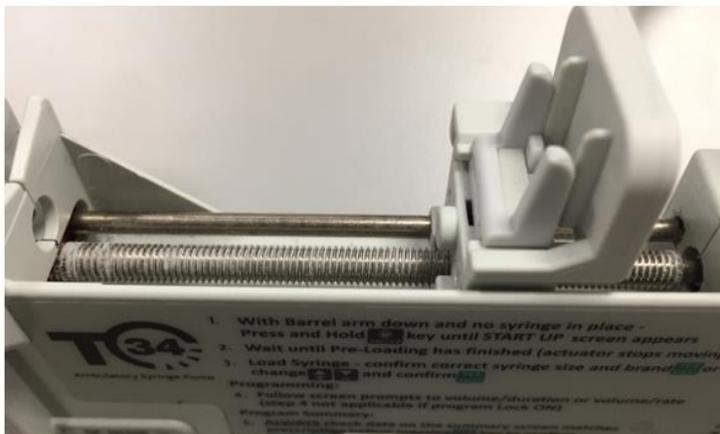
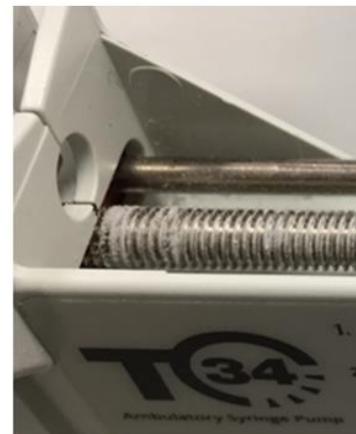
Through Post Market Surveillance feedback, BD/CME has identified that the syringe pump motor block mechanism may be affected overtime by “wear / tear”. This scenario causes **under infusion situations without the pump alarm being generated**.

The issue can be observed when the actuator does not move when the lead screw is rotating, resulting in potentially no pressure on syringe plunger to deliver the syringe contents. The cause of this issue is the actuator nut being worn enough to stop or lose traction on the lead screw due to irregular coating of the actuator. The “wear / tear” effect can be visually observed as the lead screw is progressively wearing the plastic actuator nut overtime, leaving white plastic debris along the lead screw (see Figure 1 below).

Figure 1: Lead Screw & white plastic debris

BD/CME will replace all affected units (actuator/screw) in the pump or the pump itself.

Inspect the lead screw prior to use (See 3.2 Pump Description, item 4). If there is white plastic debris on the lead screw, this is an indication of wear on the syringe mechanism. Therefore, discontinue use and send the pump for service.
