## <u>Urgent Field Safety Notice</u> <u>Needle guide bushings for stereotactic breast biopsy</u>

This letter is distributed by Siemens Healthineers on behalf of the Turon Medtech AB informing affected customers who are operating Siemens Healthineers Mammography systems with a biopsy option using TURON plastic bushings.

## Urgent Field Safety Notice (FSN) Needle guide bushings for stereotactic breast biopsy may fail

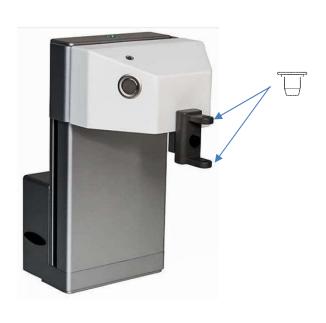
Picture 1

Sterile needle guide bushings for one-time use. These bushings are delivered sterile in pairs, i.e. one package includes two (2) bushings, according to picture 1. When using the stereotactic breast biopsy device, these bushings are used to guide the biopsy needle through the needle holder according to picture 2.

2 Reason for Field Safety Corrective Action (FSCA)*							
2	Description of the product problem*							
	Some bushings have a material defect, which makes them brittle. The degree of thi							
	material defect varies. However, some of them, may break during normal usage in the							
	field. This has happened and has consequently been reported.							
2	2. Hazard giving rise to the FSCA*							
	When a bushing breaks, parts of it may fall on the breast, i.e. around the needle's entry							
	into the breast. This may require the biopsy operator to clean the breast, remove the							
	needle and replace the bushing. This could lead to extended surgery time and a potentially							
	stressful situation for both patient and operator. No injuries have been reported due to this							
	issue.							
2	Probability of problem arising							
-	N/A

3. Type of Action to mitigate the risk*								
3.	1. Action To Be Taken by the User*								
		☐ Identify Device	☐ Quara	antine Device	□ Return D	evice	□ Destroy Device     □		
		☐ On-site device modification/inspection							
		☐ Follow patient management recommendations							
		$\hfill\Box$ Take note of amendment/reinforcement of Instructions For Use (IFU)							
		☐ Other	er 🗆 None						
	If you have any of these bushings remaining, we strongly advise you, to stop using them. We will immediately and free of charge send you replacement bushings in stainless steel. For replacement please send an email to <a href="mailto:bushing@turonmedtech.com">bushing@turonmedtech.com</a> and you will get immediate respond with replacement instructions.						ss steel. For		
		Note that these stainles with the bushings.	ss-steel bu	shings will be delivered	nonsterile. A s	sterilization	n instruction will come

3.		4. Action Being Taken by the Manufacturer							
		<ul><li>☐ Software upgrade</li><li>☐ Other</li></ul>		]IFU or labelling char ]None	nge				
	As	As an immediate action we have stopped delivery of these bushings until the issue is mitigated.							
3	5.	,		2020-05-31					
		action be complete
