Urgent Field Safety Notice (FSN) **FINGER SPREADERS 25MM D**

Date Issued: 02/2020

Commercial Name: FINGER SPREADERS 25MM D

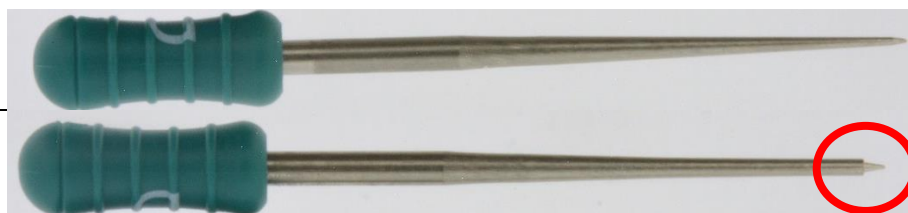
Conform Finger
Spreader

Non-conform
Finger Spreader

Description of the Product Problem: During a domestic inspection, Dentsply Sirona has detected a sporadic dimensional issue on a production of Finger Spreaders D 25mm. Some of these instruments have a diameter wider than it should be at the tip of the operating part.

Hazard giving rise to the FSCA: An incomplete / incorrect root canal obturation may occur by using such oversized instruments. Equally, there is potential risk of root fracture if the user tries to reach the expected working length by pressure on the oversized instrument.

Verify in your inventory If you could be still in possession of any affected products listed above.

In this case, please immediately segregate the products and return them to the following address:
